Shared Learning

Train struck and damaged by location cabinet door within tunnel

Ref: NRL 15/04

Location: Watford Tunnel

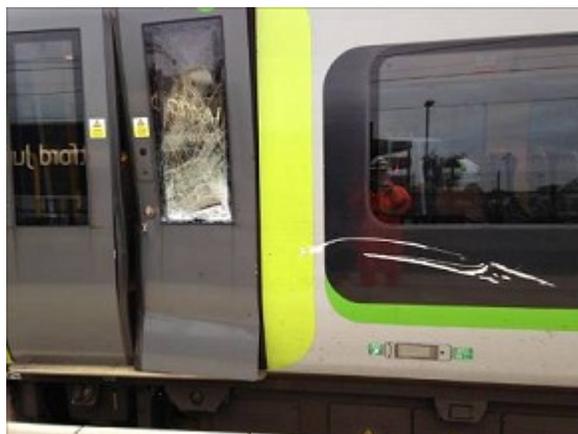
Damage to train

On investigation the driver found that a train door had become damaged and that a number of passengers had been showered in glass. Further inspection of the tunnel found that the train had struck the door of a location cabinet within the tunnel.

The location cabinet door had been pulled off its hinges and forced up, striking the wall of the tunnel and then hitting the train door.

The industry investigation identified that the location cabinet door had not been properly closed and secured. The hinged doors when in the open position were foul to gauge.

- Equipment that requires regular access for inspection or maintenance should be located outside of locations with restricted access.
- Where it is necessary to specifying equipment for use in restricted clearances it is essential to assess and mitigate the risk of any part of it being struck by a train, including in a failed state.
- Testing procedures should be organised so as to prevent a door being left unsecured and include a process for checking and securing.
