# Shared Learning from a Formal Investigation

Document ref: **NRL14/04**

Title: **Designing and installing chemical anchors for post-drilled fixings**

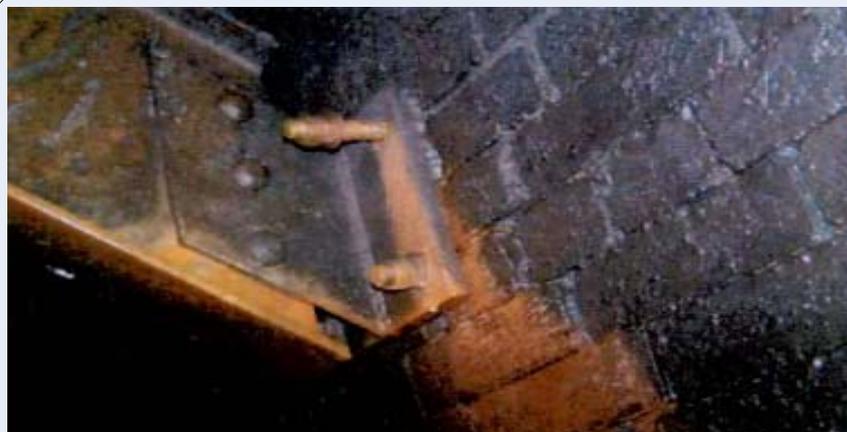
Photograph of failed stud

The design of the connection between the studs and tunnel lining was inadequate given the actions on the structure and the condition of the substrate that the anchors were embedded in.

The resin was probably selected using inadequate technical data and, with no on-site testing having taken place during the design phase, was not compatible with the tunnel brickwork. The resin that was ultimately selected may have been softened by water percolating through the brickwork; and resin shrinkage may have reduced the bond between studs, resin and brickwork.

It is probable that insufficient resin was placed round the studs during installation in 1998/9.

**Key Message:** The risk of functional failure of post-installed anchors should be addressed in Building and Civil Engineering Assurance forms (as prescribed in NR/L2/CIV/003) and accompanying design / project risk records. That process must also identify appropriate mitigation measures which should include implementing the requirements of BS 8539:2012 when selecting, designing and installing post-installed anchors in masonry and concrete.
