# Lessons Learnt from a Significant Event

## Issue Number: TLP009

**Title:** London Bridge Station Redevelopment - Spigot Failure on a Bespoke Mobile Platform

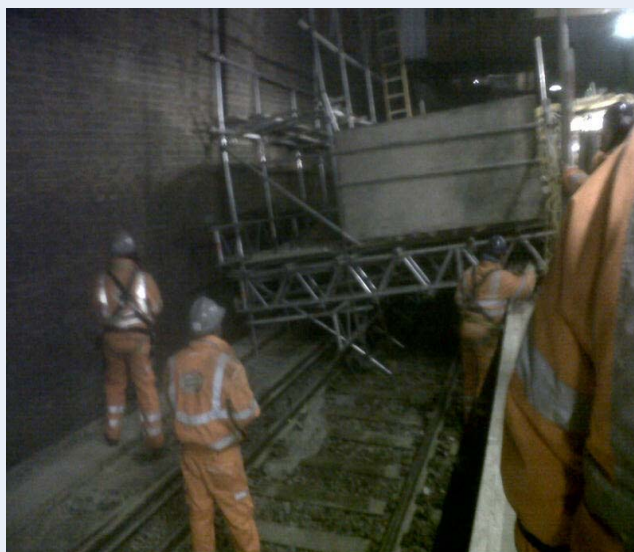
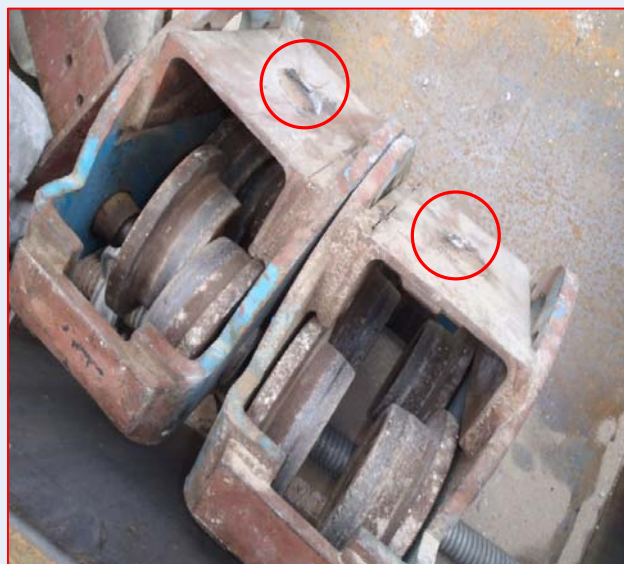
- Whilst the platform was being pushed along the track all four spigots broke away from the castor's wheels as a result of the welds simultaneously failing.

The Photographs below show the scaffold platform resting against the retaining wall after the spigot welds had failed; and also the points at which the spigots broke away from the wheel cages.

- The tower was not designed to be moved under load, however this was never actually specified in any of the documentation (design drawing/WPP/TBS).
- When demolishing the wall adjacent to the stairs, the arisings could not be removed as planned by the mini excavator without moving and repositioning the tower.
- Consequently the scaffold tower was pushed with the arisings from the demolition on the platform. The horizontal movements with a load on the platform caused the welds to fail.

- Always consider Temporary Works designs in line with the work methodology (design drawing/DRA/WPP/TB etc.), in this instance had the constraints of the platform been correctly denoted within the methodology (WPP/TB) the event would have been prevented.
- The contractor has subsequently introduced a 'safety readiness review' for higher risk and less standard work activities. Such a review would have been likely to pick up the proximity of the staircase to the scaffold tower and the issues this would cause in the planning stage.
- If towers or other equipment (particularly those of a bespoke design) have load or movement restrictions; make sure that there is effective signage on the equipment clearly stating these.
