Lessons Learnt from a Significant Event

Issue Number: TLP015

Title: Bermondsey Dive Under – Dumper Hit Metal Lintel in Archway

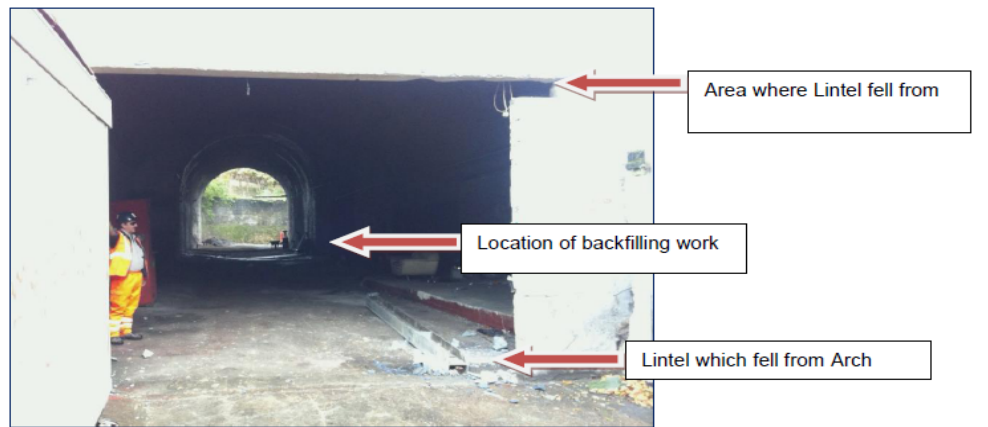
- On 4th November 2013, A dumper was accessing an entrance to an arch when the roll bar on the dumper snagged the bottom flange of a metal lintel.
- Upon contact the lintel became dislodged and fell hitting the dumper and then falling to the ground behind the vehicle.
- There were no injuries, however the rear of the dumper was damaged.

The photograph opposite shows details of the location and event

- Permitted routes were marked out in the Traffic Management Plan (TMP) however clearance / height restrictions were not addressed and therefore not communicated to the site team
- Height clearance signage was not present on machinery or the arches within the site area
- Lighting would have been reduced due to the fact that the dumper was blocking the entrance and there was no lighting internally in the arch
- There was unsuitable follow up on the fact that the lintel stability was questioned some months before the event
- The Work Package Plan (WPP) did not identify the arch height risk which therefore led to a lack of consideration to height and width restrictions for vehicles within the site

- Traffic Management Plans (TMPs) should be in place for sites
- TMPs should have route information including any clearance restrictions (height and width)
- Restricted clearances should be clearly demarcated on site
- WPPs should identify the site risks including traffic routes and have suitable controls in place
- Task Briefs should highlight both site and activity risks and controls so that these are communicated to the workforce
- Suitable lighting should be provided throughout sites including access routes
