Date: 18th December 2014

Issued By: Thameslink Programme, HSEA Team, James Forbes House, 27 Great Suffolk Street, London SE1 0NS

Issue Number: TLP 027

Title: Railway Approach Viaduct – Rivet Head Removal (26th November 2014)

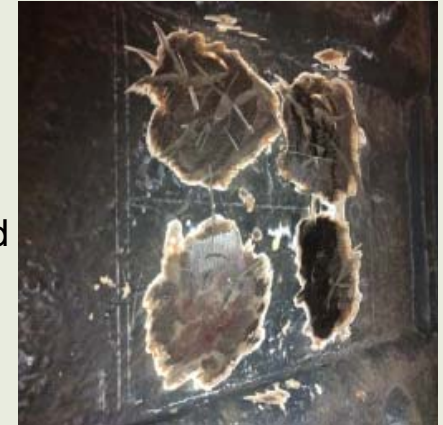
During an inspection, the Skanska engineer noticed that 16 rivet heads had been ground off. The work was suspended and the issue reported to Skanska's Engineering Manager.

Rivet Heads removed

- **Behaviours** - The fitters decided to grind the rivet heads off the 16 rivets even though the Task Briefing clearly stated to use the "one in one out" technique, & the PM had briefed them specifically on this that morning.

- **Planning / Communication** – The TBS did not mention the heads as a separate entity. It just stated that the rivets would be replaced on a "one in one out" basis and therefore it is believed there was an assumption that removing the heads would be acceptable.

- **Trying to make the job easier** - Even though there was no pressure to get the job done a few of the operatives had said they had to have the work completed for the following nightshift. They also stated that it is a quicker process to grind the heads first to avoid having to use two sets of tools at any given time i.e. the use of a grinder and rivet buster.

- Future WPP / TB requiring similar activities are to be more task specific and to state "Each rivet will have the head ground off before being punched out and replaced in it's entirety before moving on to the next rivet".
- WPP's to be updated and agreed as and when the TB's are revised as per NR Policy.
- Specific Life Saving Rules are to be included within the Risk Section of the WPP & TB. All live TB's are to be reviewed to ensure latest LSR are included.
- NR and Skanska on call reporting procedures being rebriefed to all staff to refresh peoples understanding.
