Issued By: Thameslink Programme, HSEA Team, James Forbes House, 27 Great Suffolk Street, London SE1 0NS

**Issue Number: TLP 030**

**Title:** London Bridge – Scaffold Overturn (28<sup>th</sup> January 2015)

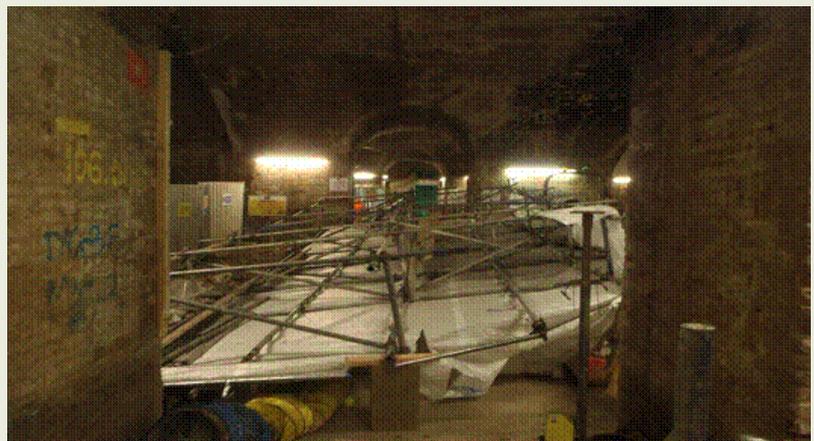
**Diagram/ Photo of event:**

A scaffold screened with monoflex was erected in area of the site to prevent the migration of debris and dust from demolition works to other populated areas of the site; these areas all being ‘underground’ in the arched structures below the existing railway station. The scaffold overturned and fell landing on a section of the Green Route (safe pedestrian walking route for the site team). There were no injuries. The scaffold was in excess of 5 metres high and therefore classified as a Dangerous Occurrence.

When the planned demolition activity broke through into the arched structure, in which the screened scaffold was erected, airflow was introduced flowing towards the scaffold. This caused a wind load on the structure and the overturn event. The absence of a suitable number of suitable ties to the surrounding structure resulted in the scaffold not being of adequate strength and stability to withstand the imposed wind load. The root cause of the event was misinterpretation of the scaffold standard TG20:13. The team incorrectly assessed the screened scaffold as falling within the guidance and did not obtain a scaffold design. Underlying causes included:

- Design – failure by the team to request a designed scaffold due to it being deemed as a ‘basic independent scaffold’. Wind loading was not considered and there were inadequate ties (2 No. screw jacks were used between the structure and the arch masonry)

- All sheeted scaffolds are now to be designed
- The request for scaffold forms now include environmental factors to be considered
- All scaffold requests are to utilise the request for scaffolding form and go via the Scaffolding Manager
- Scaffold supervisors are to undergo refresher training
- An additional scaffold supervisor will be employed to reduce workload on the scaffold supervisor
- An independent scaffold inspector will inspect scaffolding
- The roles and responsibilities of the Scaffolding Manager has been reviewed and briefed to him
- The temporary works team have been briefed on the scaffolding process
- The temporary works meeting agenda has an item added regarding scaffold installations
- A revised audit process has been implemented to monitor compliance on the scaffold process
