# Shared Learning

**COSTAIN**
**The Thameslink Programme**

**Issue Number: TLP031**
**Title: London Bridge Destabilised Wall (5<sup>th</sup> March 2015)**
**Overview of Event:**

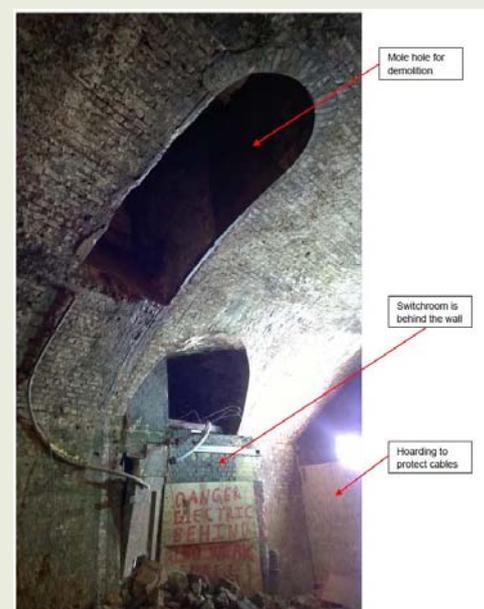
**Diagram/ Photo of event:**

A demolition contractor was undertaking loading out activity when part of a wall de-stabilised. This occurred in an area where the team were removing demolition rubble which was being fed down through a mole hole from the station platforms above. A bobcat machine was being used to load out the rubble. It was the action of the rubble being pushed by the bobcat bucket against the unprotected infill brick wall that resulted in the destabilisation.

On the other side of the collapsed wall there was an electrical switch room containing cables and switch gear.

- **Design and Procedure:** There was insufficient mitigation by way of physical protection systems to protect the electrical equipment in the switchroom. The plyboard 'barrier' installed was inadequate and the warning sign was ineffective. The plyboard failed under a load it was not designed for.

- **Engineering Assessment:** An engineering assessment of the wall was required to determine its strength and stability. Temporary works was not consulted as it should have been .

- Risk review meetings will include a joint site visit (PC and sub contractor) where the rating is medium or high.
- To prevent damage to equipment, suitable barriers will be installed in confined areas to protect 'vulnerable services' such as cables / electrical equipment.
- The temporary works department will be consulted to make sure that structures likely to be loaded receive an adequate assessment.
- A pre-start assessment of the working environment will be undertaken to make sure the WPP / TBS is adequate.
