Shared Learning

SKANSKA
The Thameslink Programme

Issue Date: 9th Sept 2015 - For further info contact sharon.fink@networkrail.co.uk

Issue Number: TLP037
Title: Working at Height – Recent Events
Overview of Event 1:

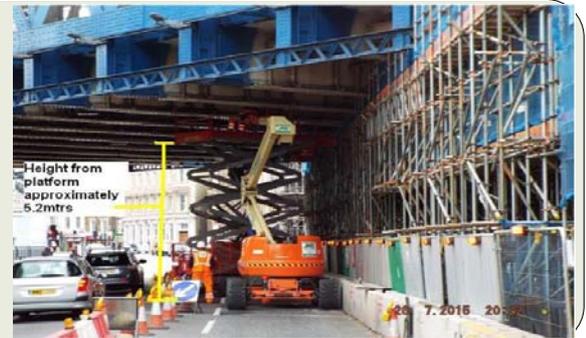
Southwark Street,
London Bridge

Whilst undertaking the installation of structural steel to the underside of a bridge, a steel erector climbed from the basket of a cherry picker onto the scaffolding adjacent to the site. The operative was restricted from completing the beam installation from the cherry picker and needed to access the scaffolding to complete the task.

Root and Underlying Causes
Event 1

- The operative identified an access issue which restricted the team from completing the task. The access issues were not foreseen during the planning and therefore did not form part of the WPP.
- The Fabricator did not communicate the required change of methodology to the other members of the Kilnbridge and Skanska team.

- Both events were breaches of the Life Saving rules and subsequently both operatives went through the Fair Culture Matrix.
- On site behavioural checks are being undertaken as a result of both events.
- Teams have been re-briefed on safety working practices and how to manage change.
- Changes occurred in both events which were not followed as per the change control procedure therefore this has now been added as a documented requirement within the WPP and TB and briefed to the site team.

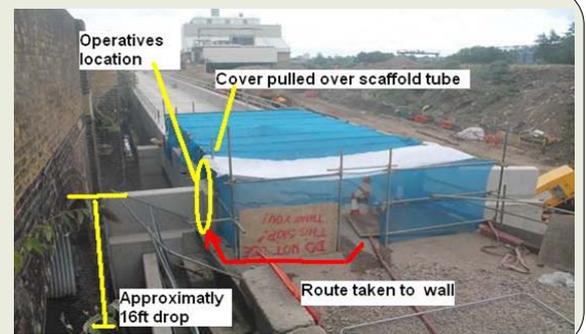
Photo of
Event 2:
Bermondsey
Dive Under

Works on site required blue netting to be placed with cable ties to a scaffold. These were all at shoulder height and behind scaffolding therefore the scaffolders were not required to wear their harnesses. The blue netting had run out and the team decided to use terram which is tougher and stronger and needed holes to be punched through to tie in to the scaffold. The operative took the action to go onto the wall on the outside area of the scaffold to do this. The scaffolder was not wearing a harness at the time. The fall from height would have been approximately 16ft.

Event 2

- This netting element of the activity was not sufficiently planned. It was omitted from the WPP and TB.
- There was a change and the change procedure was not followed - the blue netting material had ran out and so the team decided to use the Terram as a covering.
