**The Thameslink Programme**

**Issue Number: TLP038**

**Title: Damage to Train traction equipment (17<sup>th</sup> June 2015)**

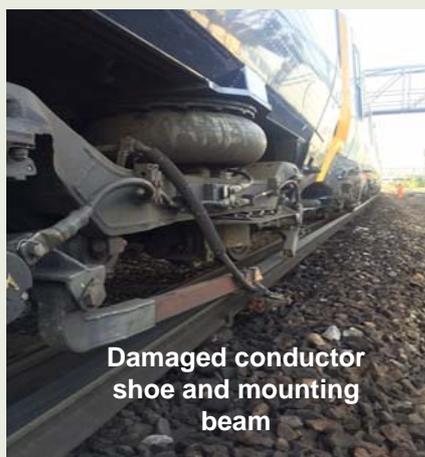
The cable was severed and left a stub sticking up in the air, which was then caught by a second train causing it to lose all conductor shoes and damaging the connector beam on four carriages and disabling the train. It appears the cable had been left sitting high on the ballast near to the conductor rail following work in the area.

Damaged conductor shoe and mounting beam

- Where cabling or other track equipment is moved for protection, arrangements should be in place to make sure its re-instated before handing back the worksite
- As part of Track Hand back processes, there are robust plans in place to check and be informed where work has been carried out
- Consider highlighting all cables with paint to make them more visible to check
- Make sure all personnel are familiar and competent in working and understanding 3rd rail traction areas

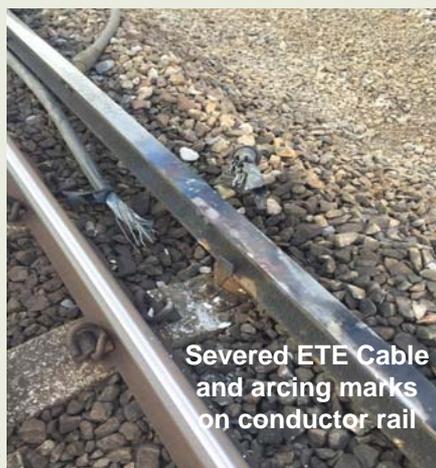
**Immediate** - An ETE cable left foul of the traction collector shoe clearance envelope of operational trains caught the conductor shoe equipment of two trains in passenger service. The first train dislodged the cable and the second train caught it around the conductor shoe gear causing detachment and damage.

- An ETE traction cable was moved on to a ballast shoulder to protect it from the movements of track mounted plant traversing along an area where a rail section had been removed. Once the cable was moved it was not returned to its original position.

Severed ETE Cable and arcing marks on conductor rail
