Shared Learning

The Thameslink ProgrammeIssue Date: 16th Sept 2015 - For further info contact sharon.fink@networkrail.co.uk**Issue Number: TLP040 Title: Acoustic Panel****Overview of Event:**

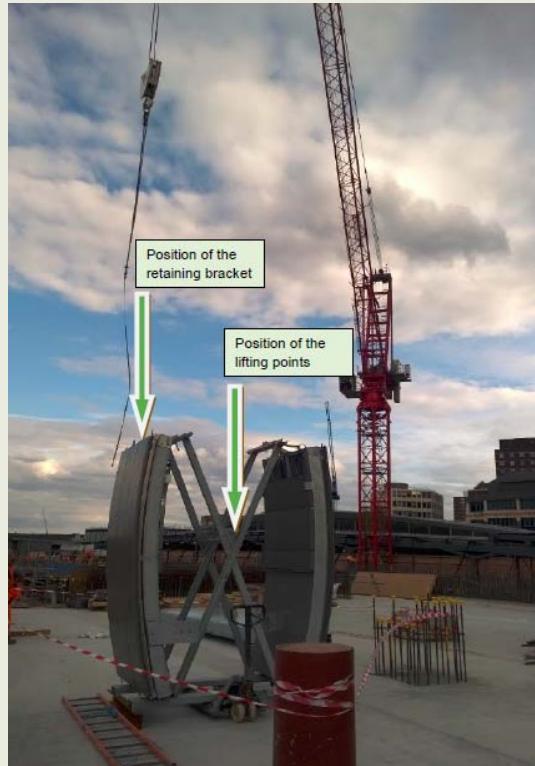
An acoustic panel became detached from its stillage frame and fell over. The panel, weighing approximately 350kg, had just been lifted as one of a pair contained within a purpose-designed support frame [stillage], direct from the delivery wagon onto the Western slab of the site. As the stillage holding both panels touched down onto the slab one of the panels detached from its fixings and fell to one side. Persons, including the Slinger / Signaller, were in the vicinity however no one was injured.

Immediate - The failure of the 'nut and bolt' fixing arrangement that captivates the acoustic panel to the stillage frame. The nut became loose allowing movement, loss of vertical and lateral restraint and subsequent detachment. It is concluded that the restraining arm was loosened during the transport to site. The security of the load [the restraining arm – panel arrangement] was not checked by the Slinger / Signaller before the lift commenced. An unsafe load was therefore lifted.

- The panel was held in the stillage at 3 No. points: 2 No. on the bottom and 1 No. on the top. These fittings are safety critical. Two design failures flow from this: first, a reliance on the single top restraining arm i.e. there was no back up should this fail. Secondly, the type of fixing specified was not adequate: the [formally unspecified] nut and washer design did not prevent the nut 'unscrewing'. A Nylock nut would not have 'unscrewed' [allowing movement and failure].

- The inspection methodology identified above was not specified in the WPP, TBS or Lift Plan.
- The bolt used to secure the stillage restraining arm to panel was not the correct bolt. There is no evidence that a washer was used. The nut became loose on the bolt allowing movement and failure.

Pair of Acoustic Panels in the Stillage

- Revised bolted fixing arrangement implemented, including a Nylock nut system.
- Introduction of a secondary means of securing the load; this includes the use of 2 No. ratchet straps installed before dispatch from the Delta works.
- Development of a stillage safety and load security checklist and monitoring regime that includes mandatory sections for: pre-loading of the panels to the stillage, pre-loading to the transport, pre-lifting off of the wagon and final check before lifting to location.
- Revisions to the WPP and TBS to include more detail on the requirements attached to the transport and associated lifting operations.
- Briefing sessions to all of the London Bridge delivery team on security of loads when transporting and lifting.
- Briefing sessions to all relevant Delta Fabrications operatives, including site installation and works yard loading teams.
