Shared Learning

COSTAIN
The Thameslink Programme

Issue Number: TLP042
Title: Paraslim – Potential Fall from Height

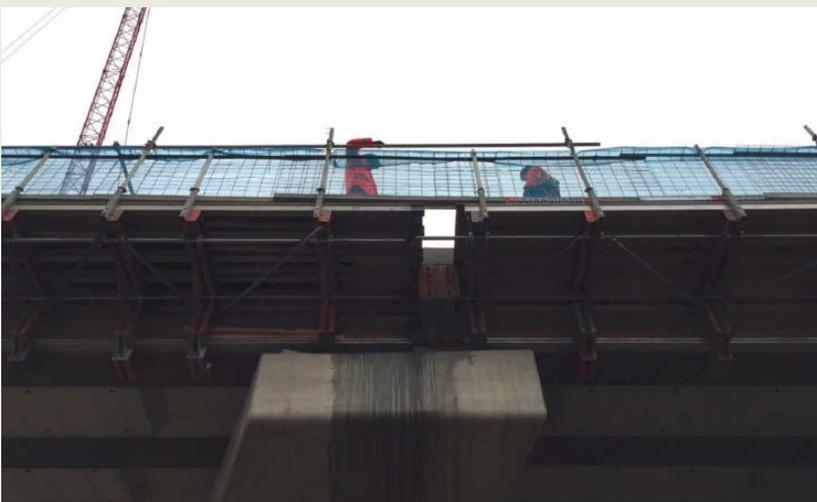
Work was being carried out to remove Paraslim sections from the southern elevation of a bridge deck when a Scaffolder stopped onto an unsupported section of ply board which gave way. The scaffolder suffered minor leg and hand injuries as his lower leg went down into the opening. There was potential that he could have fallen through the gap. The drop is 8.0 metres.

Immediate - The Scaffolder stepped on unsupported unprotected ply infill with the potential to fall through the hole resulting in minor leg injuries.

- Design - The design of the Paraslim requires 6" x 3" timbers to be installed to bridge the gap where the Paraslim aluminium beams do not butt together where the end - cast plates are positioned on the bridge deck. The 6" x 3" timbers were removed as part of the striking process and because the plywood resting on top of these timbers had no support the plywood gave way when the scaffolder stood on it.

The area immediately after the event – the gap was 400mm

- Work on the Paraslim was suspended pending a review on the methodology of works.
- All other Paraslim sections were checked and inspected for security.
- A review was undertaken of all similar works.
- Review undertaken of the adequacy of all Permits to Unload.
- Safety stand down and briefing was carried out with all the relevant trades.
- Full workforce was briefed on the initial findings.
- The TBS for Paraslim striking now includes the coordination of the teams involved: carpenters, scaffolders and slingers. The TBS includes a prescriptive safety critical sequence of work.
- Design is to be reviewed
