Overview of Event:

On the 8th April 2015, whilst loading redundant track panels onto an engineering train using two RRV's (Road Rail Vehicles) at Bermondsey Dive Under, one of the RRV's was traversing across Bridge 86A on its road wheels, as the track had been removed, when the deck plate collapsed and its wheel became wedged between the bridge cross and main girders.

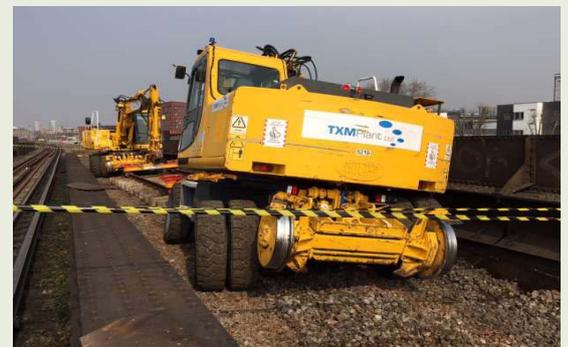
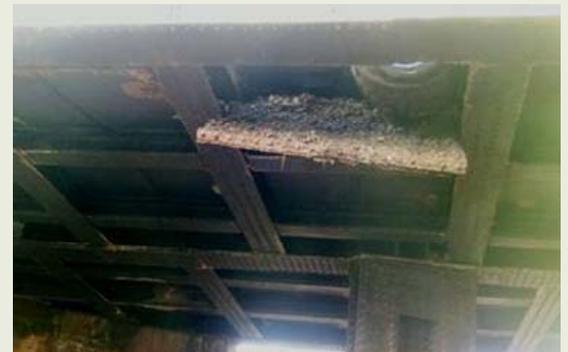
- **Risk Assessment:** Although consideration was given to the weight of Road/Rail vehicles when track mounted, once the track was lifted further assessment was not made. The point loading of Road/Rail vehicles on road wheels operating on ballast when tandem lifting lead to the failure of the deteriorated deck plates.

Above and below viaduct after event

- Risk assessments carried out as part of lifting plans consider the integrity of supporting structures and recognise point loading of Road Rail Vehicles in road as well as rail mode
- Specific pre-construction information to be requested once construction methods are determined by using Technical Query (TQ) process
- Introduction of T-8 dilapidation walkouts to understand geography of working areas
- Construction designs and drawings to include relevant health, safety and environmental risk information
- Structural information to recorded on Form B's
