Shared Learning

The Thameslink ProgrammeIssue Date: 30th Nov 2015 - For further info contact sharon.fink@networkrail.co.uk
Issue Number: TLP046 Title: Potential to Strike and Damage an Underground HV Cable
Overview of Event:

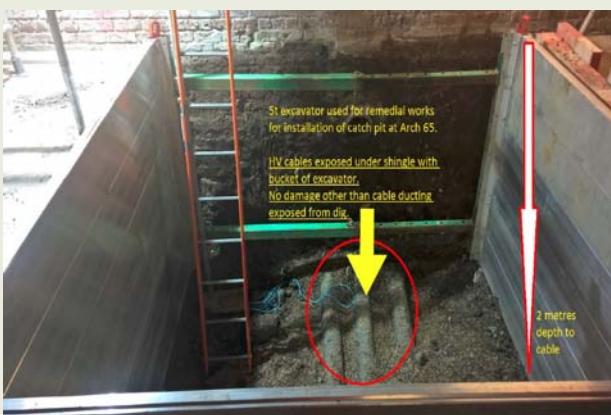
While machine excavating in the arches, at London Bridge to install a catch pit for drainage remedial work, the machine Operator and Supervisor noticed warning tape and pea shingle. These were surrounding a high voltage 20KV cable duct. The ducts and cable had been installed by the project earlier in 2014. There was no damage to the cable itself, but the pea shingle and warning tape were exposed and the works stopped immediately.

Immediate - Digging without knowledge of the presence of underground services, namely a 20,000 Volt electrical cable.

The principal causes of the incident were failure to follow established Permit to Dig processes at an individual level and inadequate recording and provision of service information at an organisational level.

Photo of Event : Excavation in Arch

- The Permit to Dig will be revised to make clearer the requirements for obtaining up to date service information.
- The process for making service information available to Permit Raisers and others will be improved to make this more readily accessible.
- The process for recording the location of services introduced by project works will be improved to ensure this is recorded before backfilling operations are undertaken.
- Permit Raiser and Responsible Person will be retrained in the use of the Permit to Dig and safe management of excavation operations.
