**The Thameslink Programme** Issue Date: 17 December 2015 For Further Info Contact [mike.netherton@networkrail.co.uk](mailto:mike.netherton@networkrail.co.uk)

**Issue Number: TLP 049 Title: Incorrectly Placed Possession Equipment**

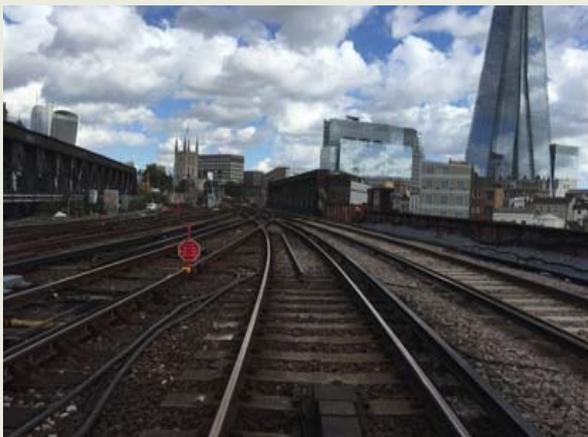
At the end of part 2 of a 3 part possession (approximately 4am) the work sequencing required the moving two Tampers from a worksite through the PICOP controlled area and onto the operational railway. To facilitate the Tamper move the detonator and Possession Limit board arrangement had to be altered resulting in a 'tighter' configuration of the equipment. Following the Tamper move, to reset the possession arrangements, the detonator and limit board locations were changed for a second time. However during the second change a detonator was placed on an road that was open to operational trains; as a consequence the individual carrying out this task put himself in a place of danger.

- Schematic diagrams do not relate exact distances pictorially around switches and crossings when detailing the track layout in complicated areas.
- No requests was made to move the protection and no permission was given by the PICOP (Person in Charge of Possession) before the protection was moved and inadvertently replaced in an incorrect position.
- To facilitate the Tamper move the arrangements meant that detonator protection could not be placed at the standard distances as per Rule Book Section 2.4 of Module T3. Whilst Section 2.5 was followed inasmuch as the detonator placed as close to the standard distance as possible; the deviation from standard was a contributory factor to the final outcome.

Section of track showing possession limits

- PICOP was stood down and an action plan put in place to rebrief, mentor and then reassess his capabilities following a Fair Culture Review
- The Engineering Supervisor was chaperoned on the two next shifts to assess his competence
- Planning Between Network Rail and Balfour Beatty has been improved, including the need to engage staff with geographical knowledge (particularly for more complex possession arrangements)
