Lessons Learnt: Local & Formal Investigations

Date: 22nd March 2013

Issued By: Crossrail West HS&E Team, Davidson House, Reading

Title: Crossrail Programme, Lookout Struck By Train

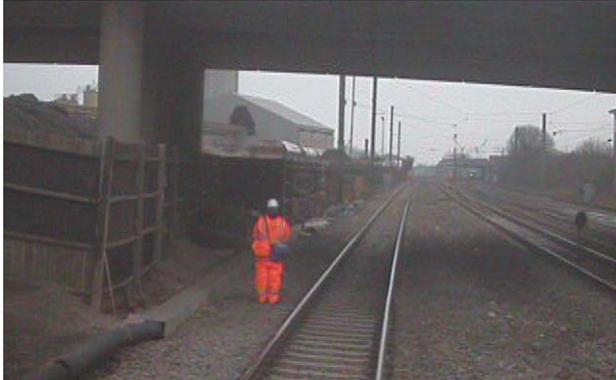
Intermediate lookout moved from a position of safety (where he had been placed by the COSS) to a position where he was standing foul of the Up Relief

- The lookout may have become disengaged from his task for some reason and this resulted in a lack of situational awareness. Some circumstantial evidence to indicate that the hood of his hooded top may have been pulled over his head at the moment of impact which could have contributed to his lack of situational awareness
- No strategy to maximise levels of protection, to reduce unassisted lookout protection to a minimum, or provide higher-level protection for multiple workgroups
- Train horn sounded only once (1.6km from area where LO was struck) – impact of 'sea of orange' on drivers travelling through Crossrail area

- Shortly thereafter, train 2P38 passed the site of the survey work moving towards London. It struck the intermediate lookout at 10.49am. The intermediate lookout was standing with his back to the oncoming train and suffered severe injuries to his right arm and shoulder.

Major programmes need to reduce the risk of using lookout protection by actively pursuing alternative technical solutions

Major programmes need to consider, as part of their risk management strategy, a means of providing enhanced levels of workforce protection (e.g. more green zones, ATWS, TOWS, or LOWS,) in situations where this could not normally be justified for a single workgroup activity.
