# Safety Advice

## Uncontrolled movement of Genie Z60 rail mounted MEWP (FR1326)

**Ref:** NRA 16/06

**Date of issue:** 11/05/2016

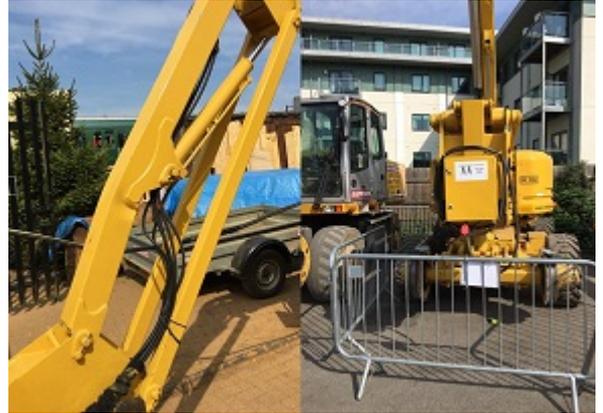
A Genie Z60 rail mounted MEWP (FR1326) rolled in an uncontrolled movement into a ballast box and RRV trailer.

In an attempt to re-set/reconfigure the MEWP it was taken out of rail mode. As the MEWP Operator lowered the rail wheels remotely from outside of the basket the brakes failed and the MEWP started to roll in an uncontrolled movement in the London direction.

As a result there was minor damage sustained to the ballast box and damage to the basket and arm of the MEWP.

Initial testing of the MEWP concerned was carried out by the Principal Contractor on Monday 9 May. Whilst the exact cause of the incident is not yet known. Network Rail has cause to believe that there is possibility of a brake override switch (for emergency recovery) having been operated which releases the machine brakes whilst activated.

- All Genie Z60 Rail Mounted MEWPs are IMMEDIATELY to be quarantined and subjected to a fleet check to ensure that the emergency override switch is correctly isolated.
- All Machine Operators and Machine Controllers MUST ensure that a full brake test is carried out as soon as the machine is subsequently on tracked in accordance with the Infrastructure Plant Manual NR/Plant/0200.
- Details of the machines quarantined and subsequently inspected are to be sent to Olufemi Okeya by clicking the link above. This shall include as a minimum:
  - 12 digit number;
  - EAC number and expiry date;
  - Converter name and contact number.
- An investigation is being carried out by the Principal Contractor and further action may be necessary once the outcome of the initial investigation is known.
