Shared Learning

Key learning following a serious incident

Langworth freight train derailment

Ref: NRL 16/01

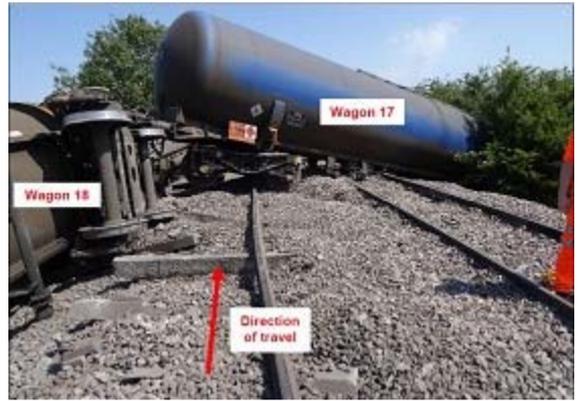
The following conditions combined to result in a failure of track stability:

1. Hot weather on 30 June 2015.
2. An inadequate ballast cess shoulder through the crossing.
3. The lateral track misalignment was detected in the previous track geometry recording but was not so significant to require rectification.

The wagons derailed to the right as the leading bogie of Wagon 11 passed over a track buckle. It is likely the track buckle developed during the passage of the train.

There were no injuries or fire but the infrastructure was damaged. Wagons 14 to 19 had to be recovered by crane.

Those responsible for managing risks (including Track Maintenance Engineers) should review the locations and processes they manage to consider whether they have any similar sites where low level factors could combine to create a higher resultant risk.

TMEs should assure themselves that all points are correctly designed and installed, with complete stressing records.
