**The Thameslink Programme**

**Issue Number: TLP055**

**Title: Mobile Scaffold Tower Blown Over**

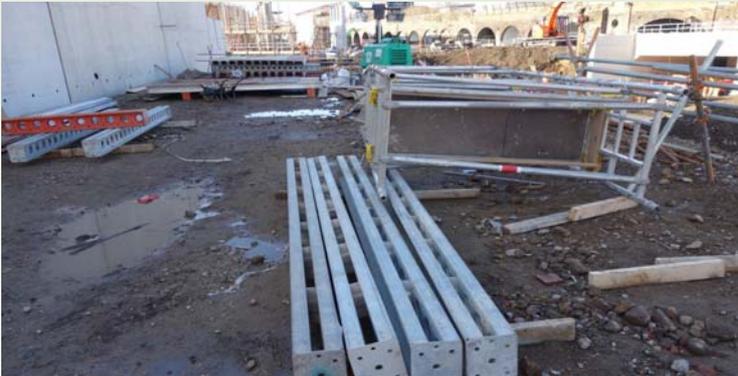
On 2<sup>nd</sup> March 2016, a four metre high mobile scaffold tower (MST) was blown over by high winds. The MST was not in use at the time of the incident and was freestanding in a works and storage area. When the MST fell towards the ground it struck a freestanding "A" Frame tube and fitting scaffold, (being used as edge protection) and then struck an operative causing a small cut to his ear, before striking him on the shoulder. The IP was wearing full PPE including his safety helmet when the falling MST struck him.

Photo showing position of scaffold after it blew over (the A frame can be seen to the right hand side of the photo)

**Immediate Cause** - High squally winds caught the MST, applying an excessive wind loading, which caused the MST to become unstable and fall over.

Evidence showed that although the MST remained erected it was not used as a working platform after the 2<sup>nd</sup> Feb 2016. The scaffold tower tag showed that it as still 'OK to use', however but should have been taken out of use.

Outriggers were not in deployed for considerable periods (not when in use but when left standing)

- A "safe start – safe finish" process has been introduced, with Supervisors appointed to specific work areas
- Daily planning meetings and morning briefings to review weather forecast for the day ahead and discuss and agree site operations that could be affected by high winds or other extreme weather.
- Training matrix reviewed to identify any gaps associated with PASMA Training.
- Hand held anemometers that provide accurate current wind speed data on site have been purchased and issued to key site supervisors and managers.
