Shared Learning

The Thameslink Programme

Issue Date: 27th June 2016 - For further info contact sharon.fink@networkrail.co.uk
Issue Number: TLP057 Title: Escalator End Panel Fell

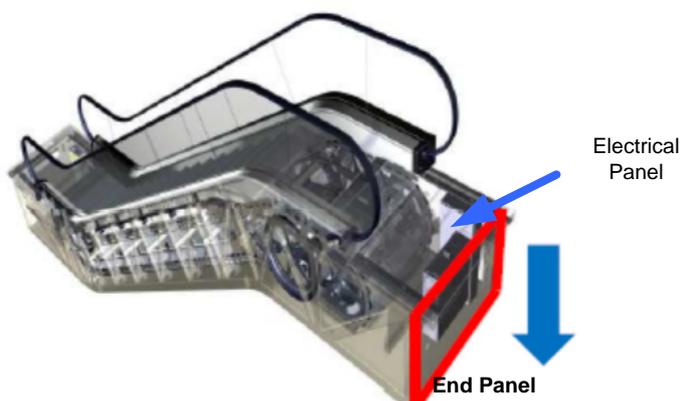
During the escalator installation process, a steel end plate at the top of the escalator being installed detached and fell 10 metres to the new concourse level below. The escalator was one of a pair being installed to provide access to platform level. Immediately prior to the plate falling, the installation team noticed it was loose. The installation supervisor was aware that other Contractors were working below (not directly) and took immediate action to inform the other Contractor's Supervisor to withdraw his men from their work area. An exclusion zone was then created using chapter 8 barriers. Within a short time (approximately 1 minute) the plate fell and struck a chapter 8 barrier cutting it in half. The end plate is a permanent component that is attached to the main structure of the escalator during manufacture. The fastenings are pop rivets. All rivets holding the end panel in place failed allowing the plate to detach. The other escalator was inspected and it was discovered that all of the rivets with the exception of 1 had also failed. This end plate was safely removed in a controlled manner. There were no injuries however there was a high potential of significant injury to persons working in and passing through the area below this activity.

Fig 1 Diagram of Escalator with End Plate Location Outlined in Red Arrow Shows Direction Plate Fell

Immediate Cause – Failure of pop rivet fixings that secured the top end plate to the escalator frame.

Design: The design did not identify the loading on the end plate. The fixings were critical to securing the plate. During transportation and storage, the electrical control panel, weighting approx. 120kgs imposed a local load on the end panel. This load was transferred to the pop rivets, resulting in sequential failure.

Hardware: The pop rivets were not of adequate capacity to withstand the load imposed and failed.

- A secondary plate has been introduced inside the escalator frame to prevent the electrical panel exerting pressure on the end panel.
- Allen bolt fixing arrangement implemented in addition to the pop rivets.
- A pre-lift checklist and monitoring regime implemented for checking when lifting off wagons and before lifting into location.
- Project documentation updated to include specifics on inspections.
- Briefing sessions undertaken for all staff involved in the escalator works.
