Shared Learning

The Thameslink Programme

Issue Date: 27th July 2016 - For further info contact sharon.fink@networkrail.co.uk

Issue Number: TLP061 Title: Glass Reinforced Panel Fell

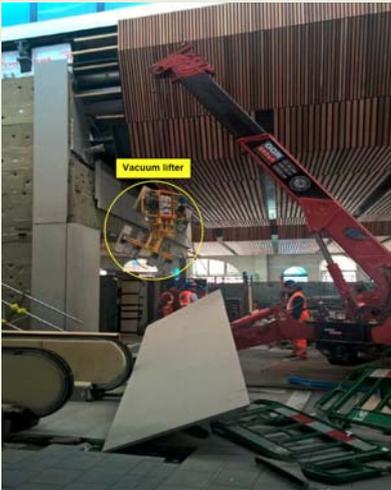
Photo of Event :

A Glass Reinforced Concrete (GRC) panel weighing 362kg became detached from a vacuum suction lifting device (GGR 1000) and fell to the ground hitting the Spider crane outriggers and the installed escalator. The Spider crane was being used for the lift. The panel was being lifted as part of the works to install cladding on the south elevation of a retail unit in the new station. There were no injuries but there was some damage caused to the GRC panel and the out rigger of the spider crane.

Immediate Cause – A collision between the GRC panel as it was being lifted and the [static] crane resulted in a loss of seal between the vacuum lifter suction pads and the surface of GRC panel; this caused the 362kg panel to fall.

Procedure: The lifting operation was not adequately covered by a Lifting Plan and Lift Permit [e.g. insufficient detail and incorrect personnel].

Procedure: The lift was not adequately supervised. A Lift / Crane Supervisor was not in attendance.

Procedure*: There was no evidence that the vacuum lifter equipment was being inspected before use or on a periodic [weekly] basis i.e. as per PUWER. This demonstrates a lack of control and supervision of work equipment.

Training: The operatives did not have the necessary training to carry out the lifting operation [not slinger / signallers]; this resulted in loss of control of the activity; this resulted in loss of control of the activity.

- All documentation was reviewed, updated and briefed including Work Package Plans and Lift Plans
- Competencies of team reviewed to operate equipment
- Pre-use check regime implemented
- Additional safety inspections introduced
- Observation system introduced to oversee the activity
- Dedicated Appointed Person resource employed
