Independent report

# Runaway and derailment of a rail vehicle near Bury, Greater Manchester, 22 March 2016

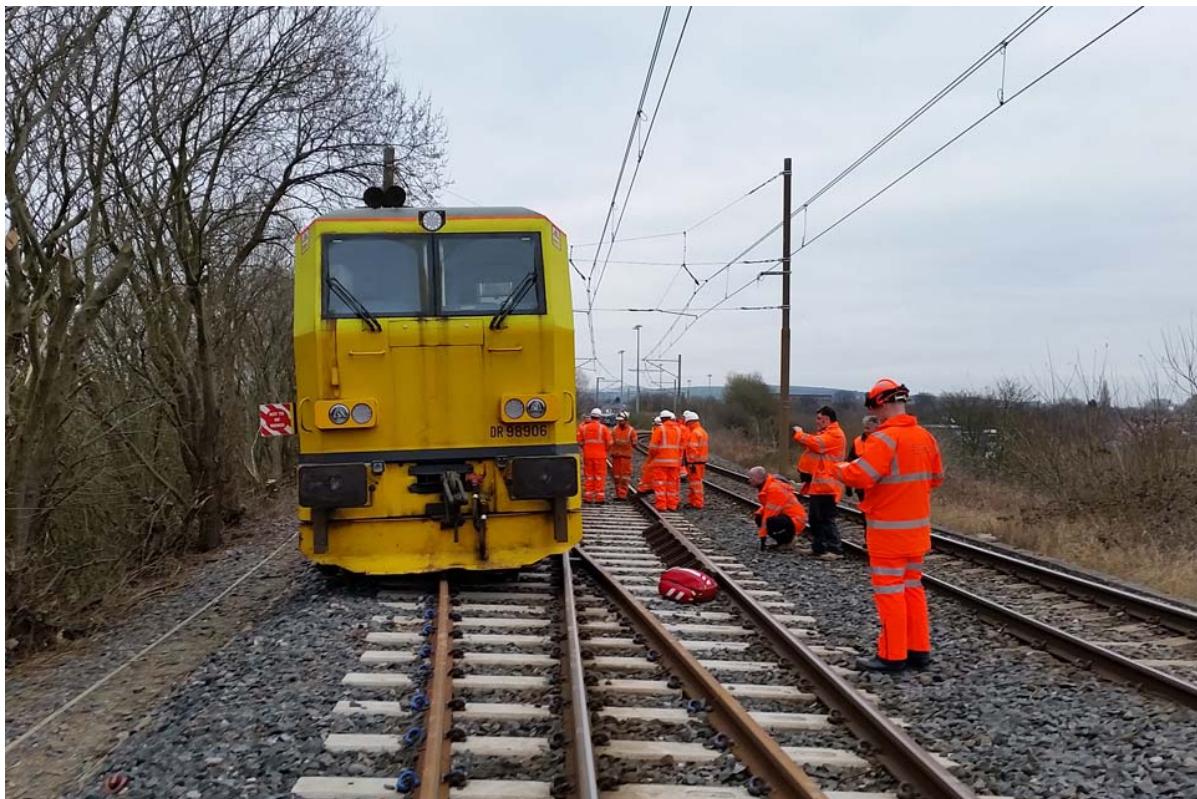
A multi-purpose vehicle (MPV) ran away down a gradient during fault-finding of the vehicle's air braking system. The MPV left the East Lancashire Railway's infrastructure and entered the off-street section of the Manchester Metrolink light rail system, where it derailed on a set of trap points. No-one was injured as a result of the accident. However, the MPV was damaged and came to rest foul of the northbound Metrolink line between Radcliffe and Bury tram stops.

The derailed MPV

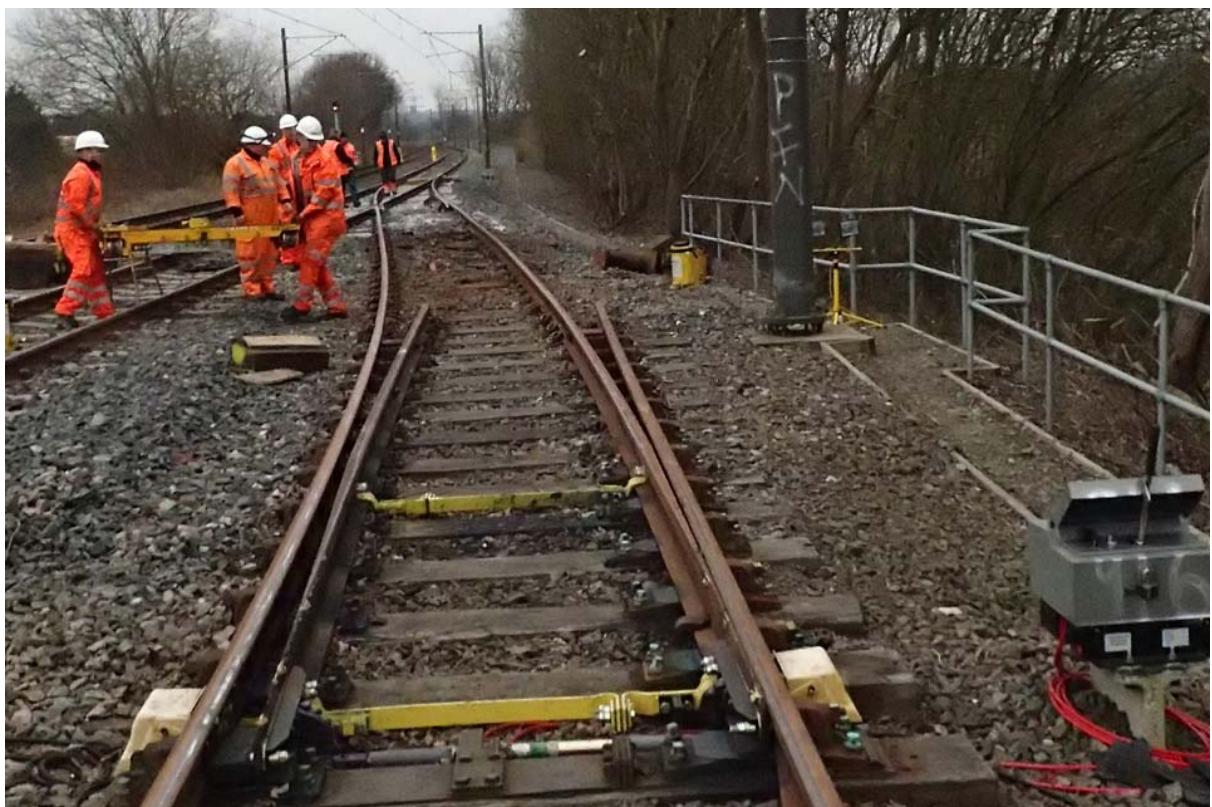
Once on Metrolink infrastructure, this connecting line passes over a set of hydraulically operated points (304 points, which consist of an 'A' and a 'B' end). When set normally 304A points direct northbound trams to Bury, while 304B points act as trap points which are intended to derail movements from the yard towards the cess and away from the tramway. The cess is bordered at this location by trees and an embankment.

**304B points. Shown set to 'reverse'**
