Independent report

# Signal passed at danger near Ketton, Rutland 24 March 2016

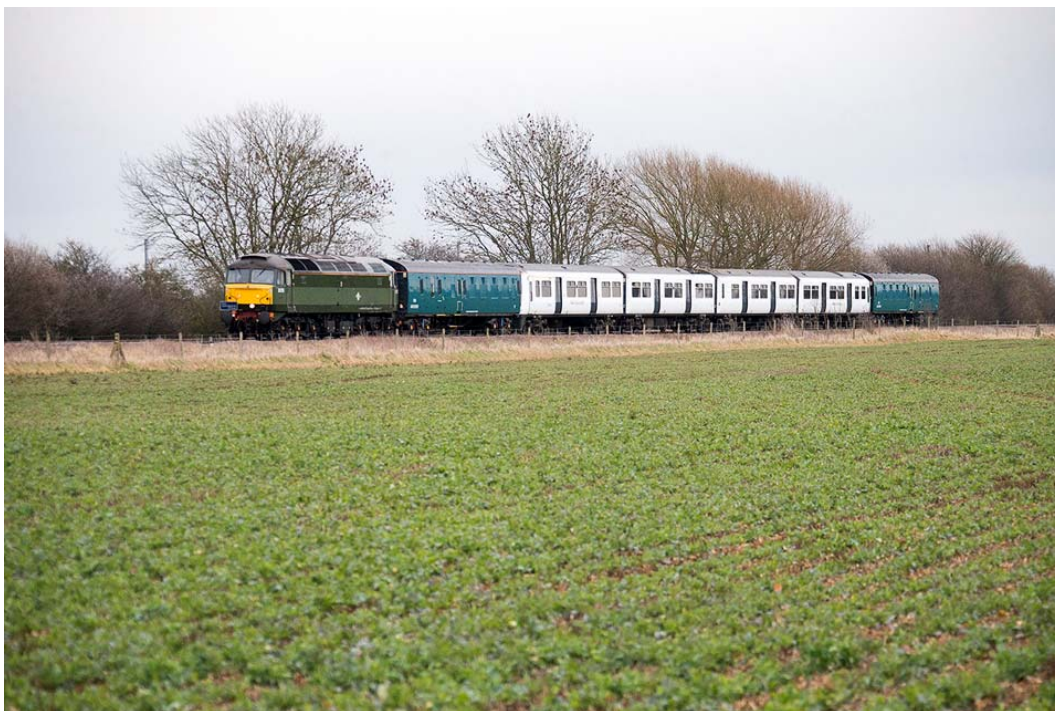
The train involved in the SPAD, shown on an earlier journey. From left to right, the locomotive, the leading translator vehicle, the EMU and the rear translator vehicle. Image courtesy of Dave Lazenby.

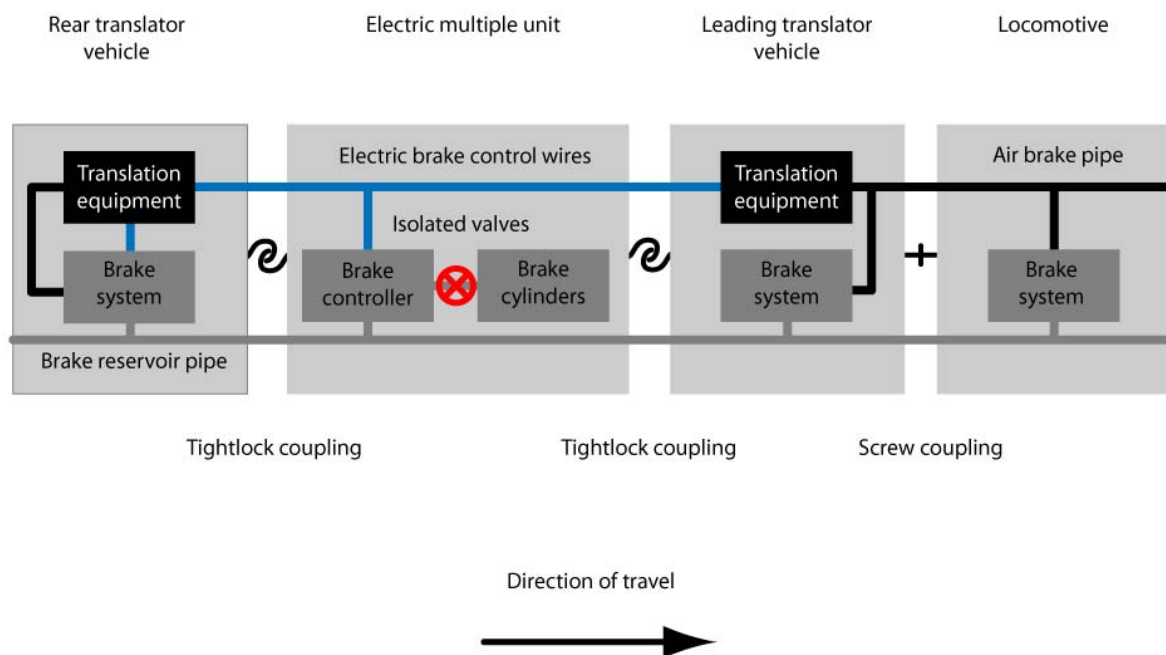
At this time the brake cylinders in the EMU were isolated, and so would not have responded to the electric brake control signals generated by the lead translator vehicle. It is not clear when the EMU brake cylinders had been isolated (by closing isolating valves), or by whom, but this is likely to have been done prior to the ROG staff preparing the train. However, despite the isolation, the electric brake control signals were still able to pass through the EMU to operate the brakes on the rear translator vehicle, resulting in the successful brake continuity test. Omission of the test in the EMU cab meant that the driver and shunter did not identify that only the locomotive and both translator vehicles had effective brakes, while the four vehicles of the EMU were unbraked.
