Share with Pain

SwP 011/15

Signal T2865 post collapse – initial SwP*

Infrastructure Projects

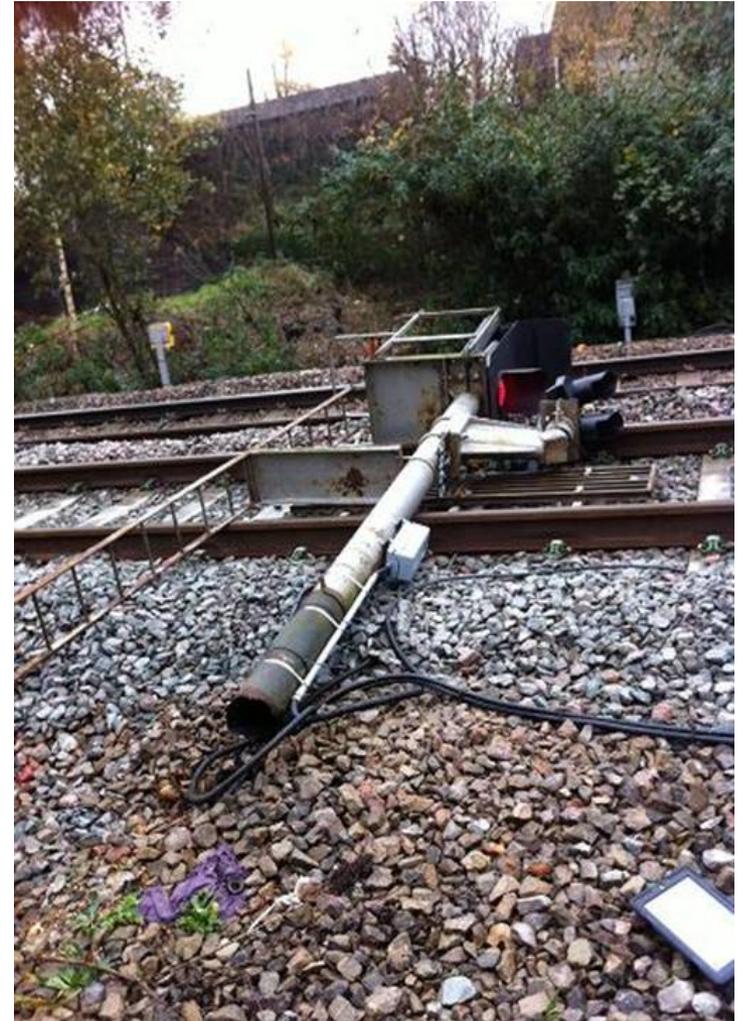
Immediate investigation revealed that a retained structure had failed at the base of its post and collapsed onto the track.

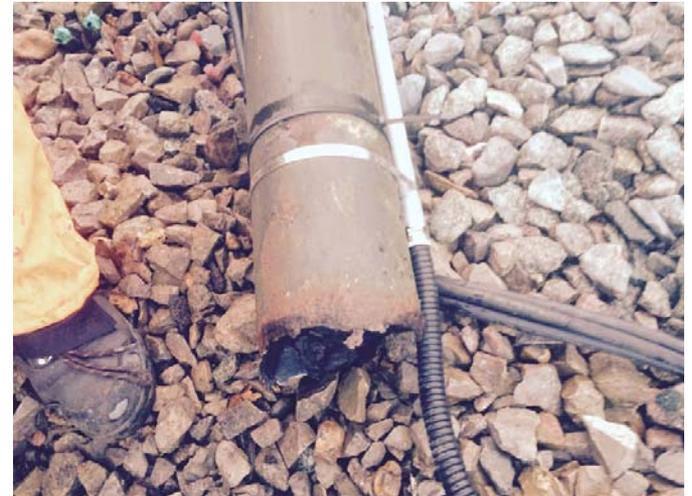
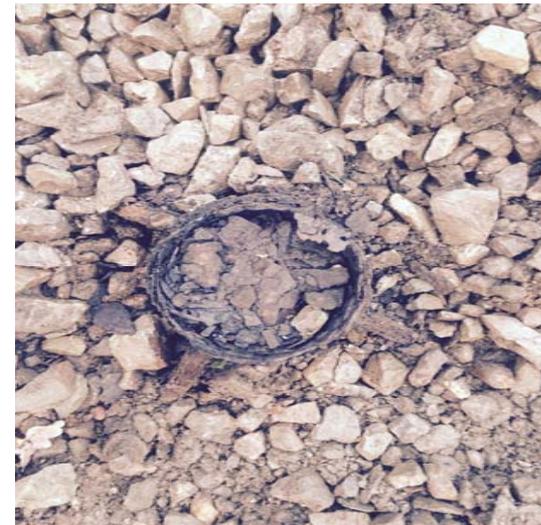
The post supporting signal T2865 failed catastrophically, causing the signal to fall onto the Up and Down Westbury lines.

Inspection of the failure revealed significant corrosion occurring around and below the ballast line.

There was no advanced warning that the structure was about to fail other than signs of corrosion of the post and ladder.

All retained signal structures on the Reading Outer Scheme were subject to an immediate inspection.

- ▶ **Inspections to determine the life of a structure need to fully assess the condition of the entire post and fixings, including any elements not immediately visible. A simple visual inspection is not sufficient.**
- ▶ **Any issues identified shall be reported to Route Control immediately.**
