Share with Pain

SWP 012/15

Watford Commissioning (Wembley Fringe)

Infrastructure Projects

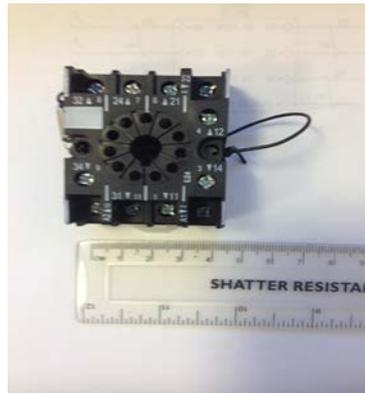
The cause of failure was attributed to an incorrectly wired Furse unit base in location 15/427. This was an existing base that had a strap added as part of the data link change work for Wembley Central interlocking commissioning.

The strap added to the base should have been terminated between terminals 3 to 8 however it was fitted from 1 to 3 resulting in the 100 ohm resistor not being in the circuit as designed.

During the commissioning, a Furse unit base was incorrectly wired in location 15/427. This was an existing base that had a strap added as part of the data link change work for Wembley Central interlocking commissioning. The strap added to the base should have gone from terminals 3 to 8 however it was fitted from 1 to 3 meaning the 100 ohm resistor was not in the circuit as designed. This affected Data Link A.

A compounding independent failure occurred on data link B, where the Furse unit had actually failed. This was determined as having occurred during the commissioning (at time of re-energisation of the OLE after works were completed).

Faults that were experienced on the data links were not just attributable to the incorrect strap in the Furse unit, as two further existing Furse units were also changed. The faults were eventually rectified.

- Undertake a thorough risk assessment of the impact of allowing and accepting the programmed possession to be changed against the signalling works planned.

- If feasible, the system should be subject to data link testing prior to energisation of OLE (full system operation). It may not be possible in all cases to do this, but it should at least be considered.

- The system should be subject to data link testing subsequent to the commissioning to ensure fault free operation after intrusive modifications have been made. This is considered to be good practice.
