Share with Pain

SwP014/15

Non-Commissioned Equipment – TPWS/AWS interventions and unshielded signals.

Infrastructure Projects

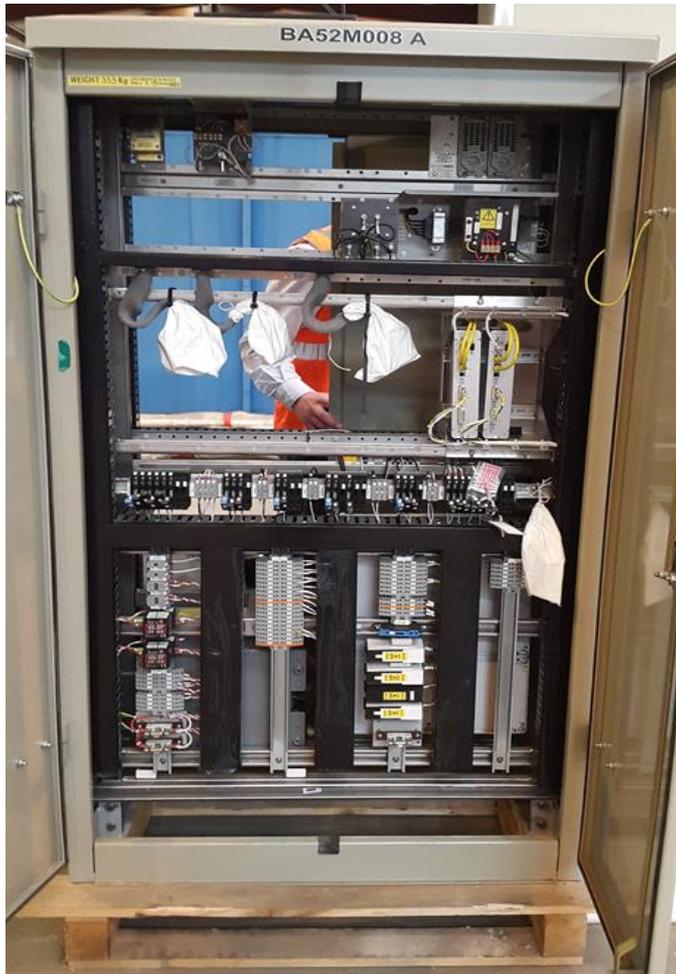
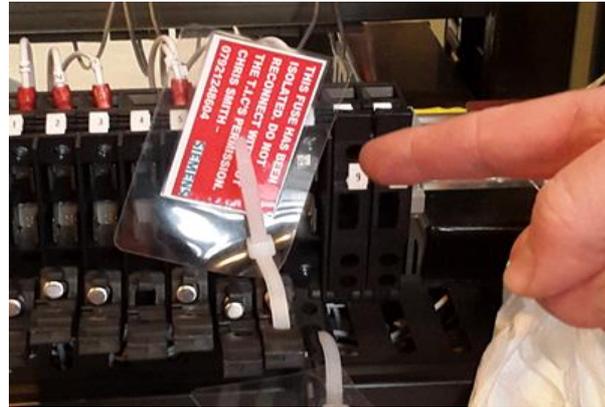
1: Un-commissioned TPWS erroneously energised

- Following power up of a location case in preparation for a resignalling project, a new TPWS OSS loop was left incorrectly energised in the operational environment. This led to the activation of the braking system on two passenger trains.

- In this case, the primary control for isolating TPWS/ AWS fuses within location cases was to cable tie the fuse carrier and apply warning labels as part of the depot testing.

- This methodology was fully complied with, however, a human error occurred 14 months in advance of the incident when the cubicle was manufactured such that the wrong fuses were isolated in the depot i.e. fuses 6, 7, and 8 (as delivered from manufacturing) instead of fuses 7, 8, and 9.

- The site tester verified the depot test sheet was signed & carried out a visual inspection to confirm that three number fuses were isolated as expected, without fully checking the correct fuses were isolated.

To mitigate against future instances of this type of failure it is recommended to:

- Review location manufacture / testing process with a view to completing all function testing prior to shipping to site / depot.

- Consider options such as removing fuses from fuse carriers in the factory and deliver to site in a bag with an inventory (Robust communications between the factory and site must be in place if this method is used due to the need to recheck fuse type and rating when reinstalled).

- Isolation of TPWS baseplate links 3&4 (Diverse isolation)

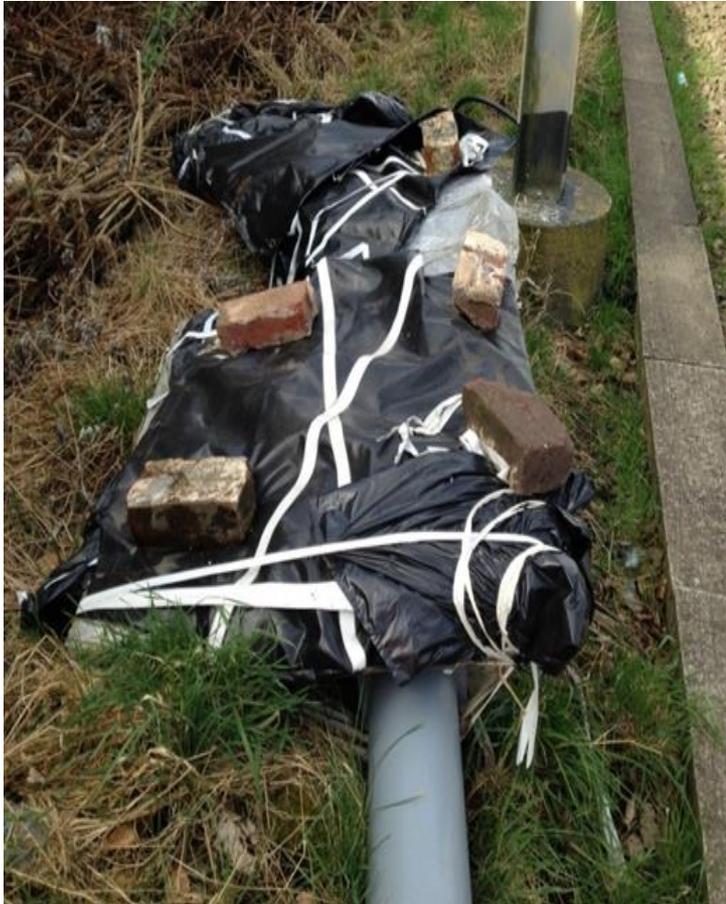
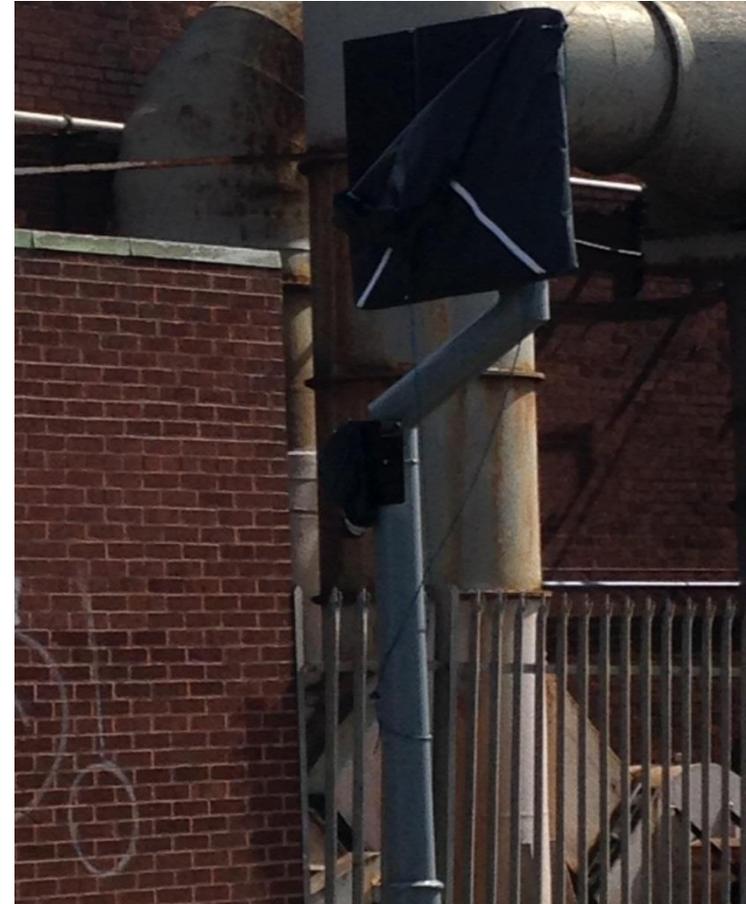
- On a recent Re-Signalling Project, a signal with a position 1 position light junction indicator and an out of use subsidiary signal was incorrectly shielded.
- A bag had become detached from the sub signal and construction staff were instructed to replace it. It was incorrectly assumed that the PLJI read onto the out-of-use loop and so the bag was incorrectly replaced onto the PLJI rather than the sub signal.
- The problem was identified and rectified later that day and no incident occurred, however should a signaller have set a route that used the PLJI for the lower speed route, a driver would not have seen the PLJI and assumed that the higher speed route had been set.

Examples of poorly shielded signals on a recent Re-Signalling Project

- The importance of shielding the correct signal, using the correct shield and correctly applying the shield should be highlighted to all Project Teams. Incorrectly shielded signals can cause confusion to drivers, and have the potential to cause more serious consequences.
- Suppliers are reminded that the correct shields should be ordered at the same time as placing the order for all signals, and the shield should be secured to the signal to reduce the risk of it becoming detached.
- A schedule should be produced for all signals, to enable construction and testing staff to ensure that all signals are correctly shielded. A check should be undertaken that the schedule has been correctly implemented. Staff should refer to stage plans at both the commencement and completion of tasks to ensure that the correct shield is used, and the shield is correctly applied.
