# *Share with Pain*

# *SwP018/16*

*Purley T1649 Points*

*Infrastructure Projects*

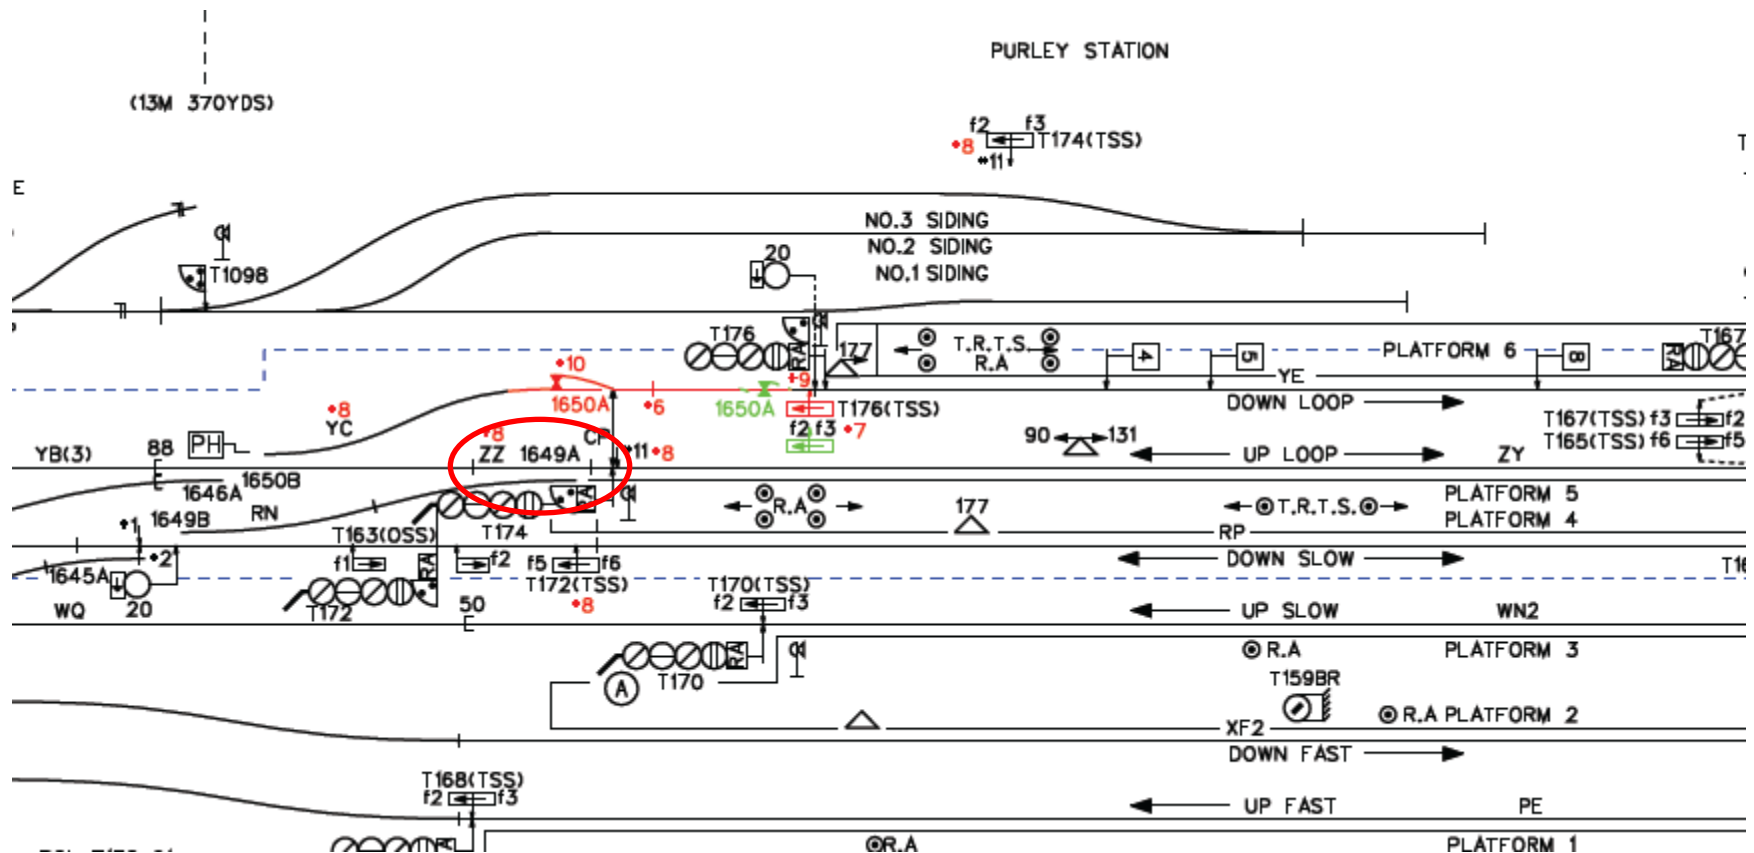
Scheme plan extract for the work to be undertaken

As part of a series of stage works for the Sussex Platform Lengthening Project the cabling to 1649A clamp lock points was removed and re-instated via a different location case, to enable installation of the adjacent trap points 1650A.

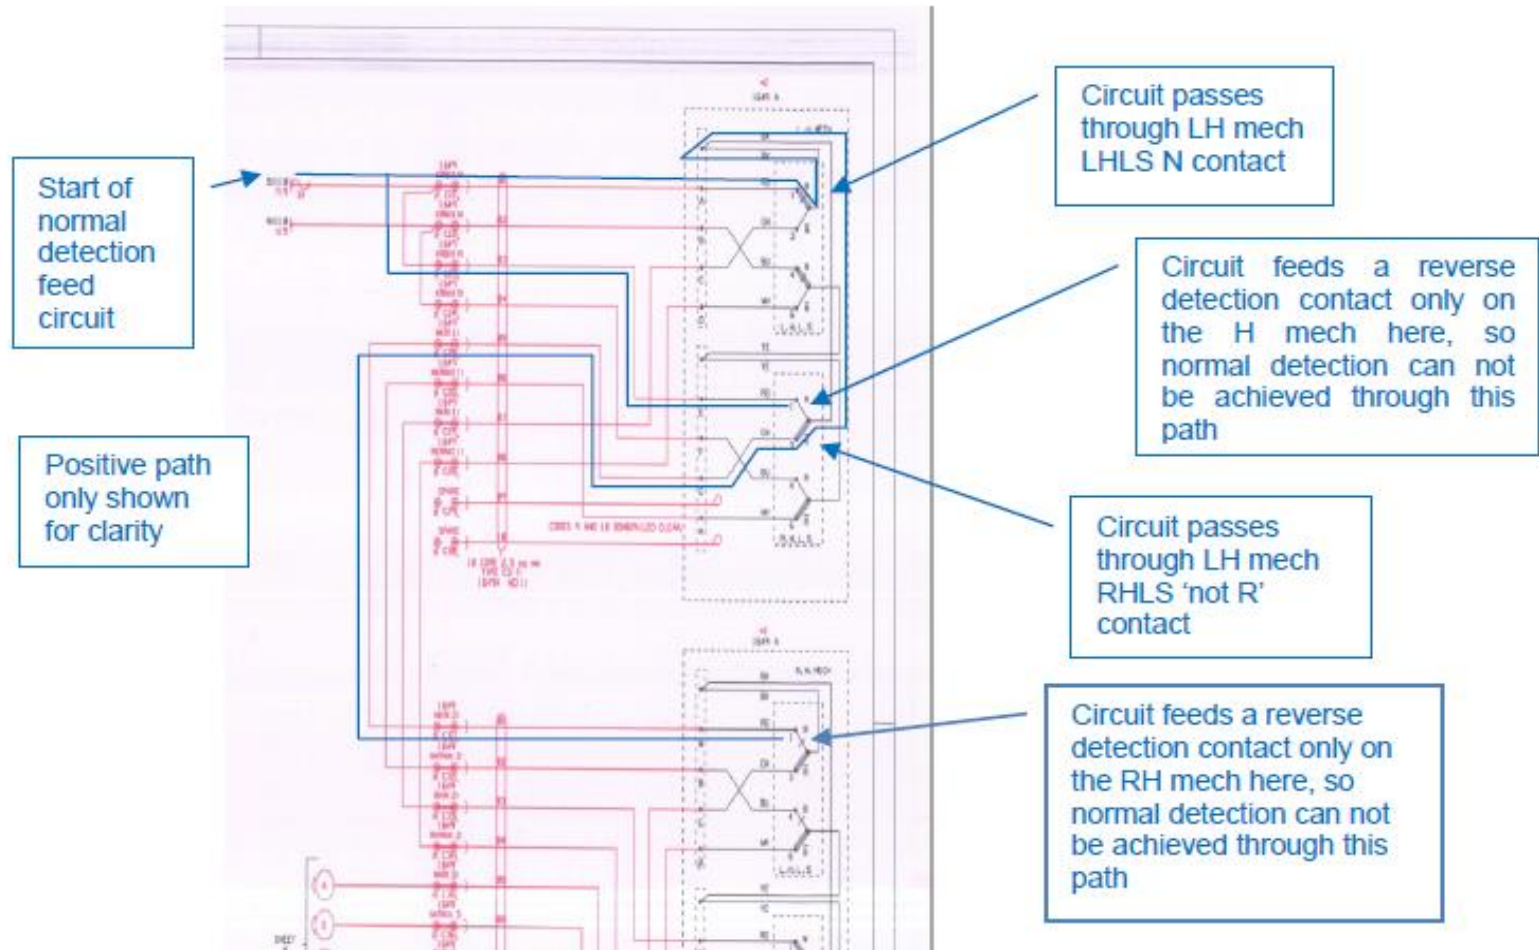
# Extract of issued design

During this work, an error was introduced into the circuitry, which meant that on the left hand detection mechanism, the left hand limit switch had a permanent feed on both sides.

Revised stage design issued included a copy and paste error, which was identified by the site tester. However the issue of test log was significantly later than the verbal notice to designer.

Neither maintenance copy nor the issued design showed the existence of dis-box, with cross connections. Therefore tester assumed straight connections in the dis-box.

**Error introduces a right side failure (detection not given)**

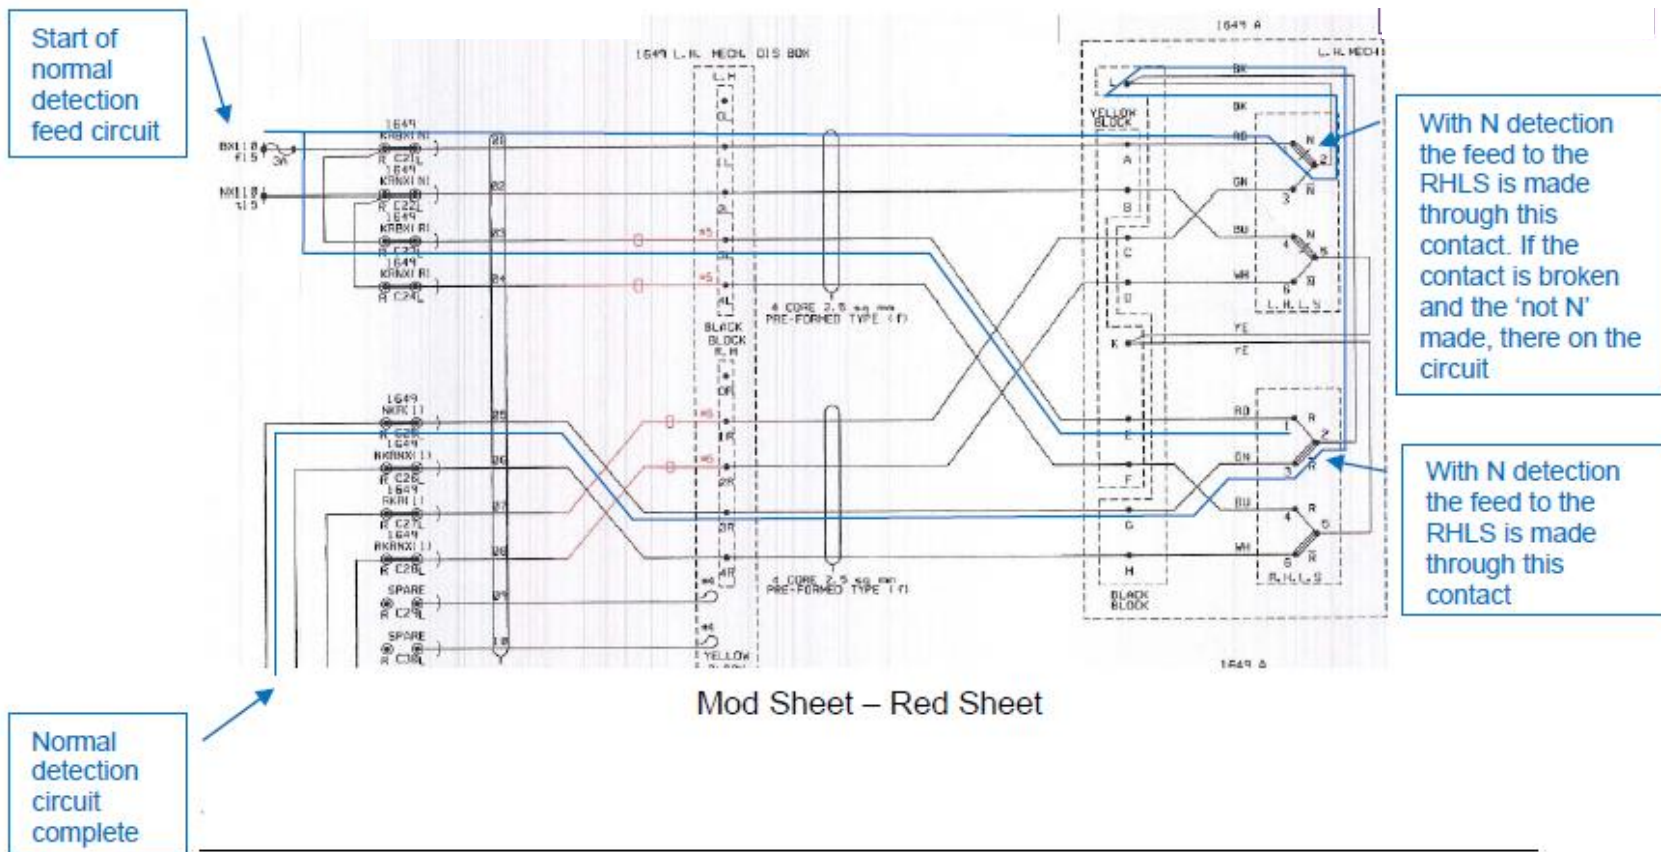
# Extract of issued design modification

## Error corrects the wrong side failure

- ▶ Immediate actions were to protect the safe operation of trains by clipping and padlocking the points normal until design modification was implemented and robustly assured.
- ▶ The wrong side failure was subjected to formal investigation.
- ▶ Project implemented an additional level of independent checking for the remainder of work.
- ▶ Competency management actions were taken for testing staff.
