Share with Pain

SwP20/16

Polegate Axle Counter Positioning Error

Infrastructure Projects Signaling

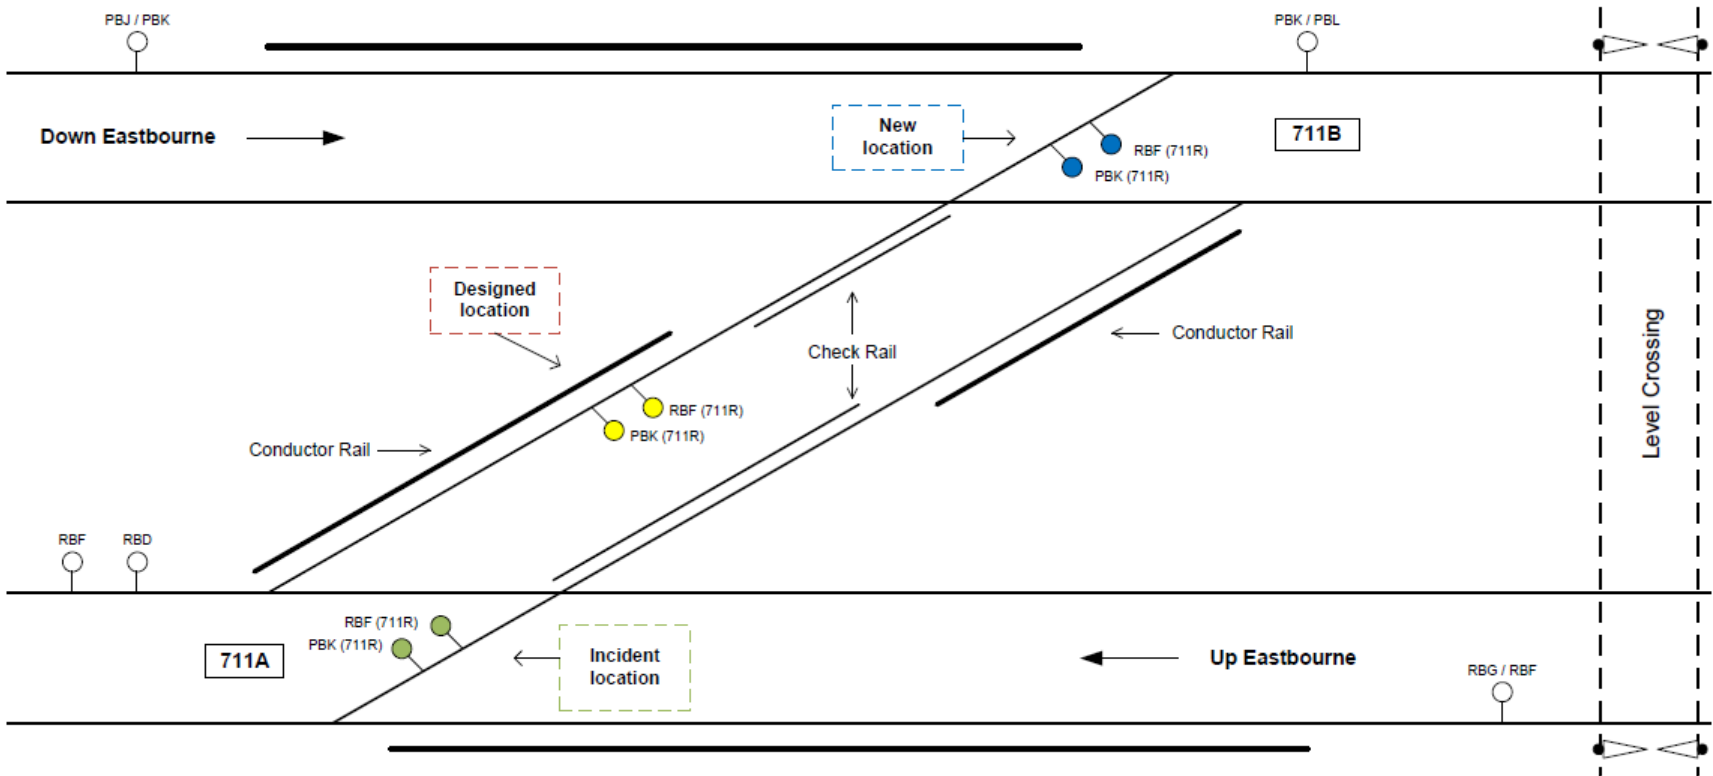
Maintenance technicians ascertained that as the train passed out of PBK section into RBF, the Advanced Evaluator Board (AEB) showed an axle count of 32 axles on PBK section (ie 4-car train counted twice) and the Input/output Extension Board (IO-EXB) displayed error code E.16 (error number = negative count).

Maintenance technicians then identified that the axle counter heads were not installed as per the design drawings and the route over the axle counter head was signed out of use.

Yellow – original design
Green – original install
Blue final position.

- Design was issued using the axle counter head sighting form and location drawings.
- The installation of the heads did not follow the design, as compliance with the design required installation on the rail closest to the conductor rail.
- The installed heads position was not effectively communicated to Design. Information supplied to the designer using the axle counter head sighting form was unclear as to what the actual installation was.
- Design did not clarify information supplied from site.
- The testing did not identify that the heads were on the wrong rail using the sighting form or map on the location drawing.
- The test specification in use at the time (since updated) did not include a test that identified that the heads were installed in the correct order (heads are bi-directionally configured on the crossover).

The design required an undesirable installation (heads on rail closest to 3rd rail).

The axle counter head sighting form did not include important and obvious site orientation information (station, level crossing).

The site installation did not take account of the importance of the correct orientation of the heads.

Information between design and construction was not effectively controlled or managed. The 'as built' was therefore not validated by design.

The testing did not effectively capture the issue and did not use all of the supplied documentation as an integrated design package. A number of different teams completed different parts of the testing and this was also not integrated as a complete testing solution.

Heads repositioned 15th May and route signed back into use.

Competent [design] representation is required to assess site installation of axle counter heads (critical higher risk installations).

Axle counter head sighting form needs to be reviewed for completeness and relevance. Atkins are contributing to a cross industry working group on this.

Where multiple test teams complete an activity each must be aware of the completion criteria required by the design package and testing documentation.

Frauscher Testing spec to be updated to include check of direction and rail configuration. Atkins have issued a formal internal brief relating to the above. PEM T&C team to take forward for NR SWTH.
