Smouldering head torch

Ref: NRB 17/03

Date of issue: 23/02/2017

Location: IMDM Motherwell area, Scotland Route

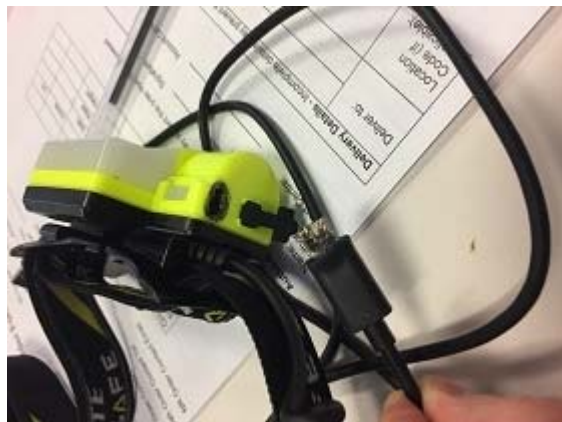
Later that afternoon the member of staff discovered the head torch smouldering whilst charging.

This investigation flagged up that the head torch was being charged with a non-standard (not the manufacturer's) micro USB cable.

The cable shorted and started to smoulder but luckily the circuit protection on the head torch avoided the battery from overheating which is why only the outer casing showed signs of burning.

- How do you check that you are using the manufacturer's equipment to charge your devices?
- What would you do if you did not have the correct equipment to charge your devices?
- How do you check your cables for defects prior to use?
