Runaway and derailment of a locomotive, Toton sidings, Nottinghamshire, 30 October 2016

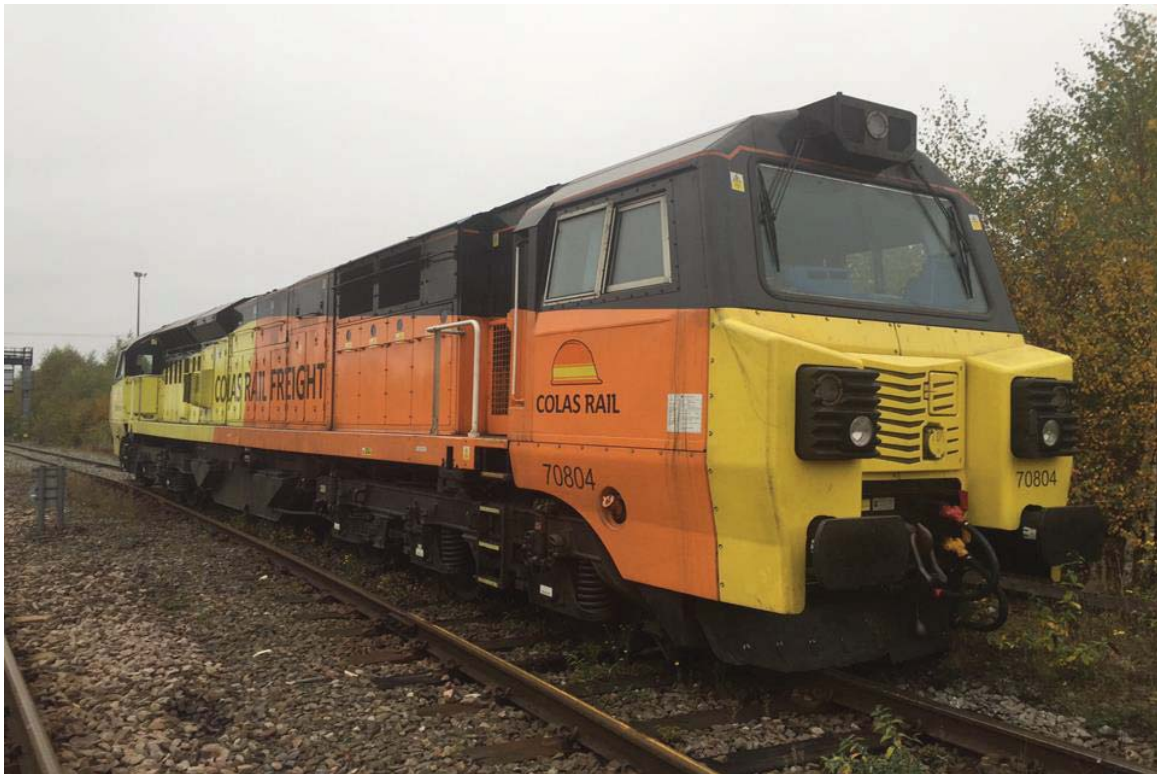
At 13:40 hrs, Class 70 locomotive number 70804 ran away while it was being prepared to be attached to another train. The locomotive had just arrived in Toton sidings at the rear of a train. The driver and the shunter, who were preparing to move the locomotive, were unable to stop it. It ran down a gradient out of the yard and onto a running line; the independent goods line. The locomotive ran for 6½ minutes and travelled 880 metres before it derailed at trap points at the end of the independent goods line.

The locomotive derailed at the trap points (photo courtesy of Network Rail)

The locomotive ran away because its brakes had been isolated, it was no longer attached to other vehicles and it had not been scotched.

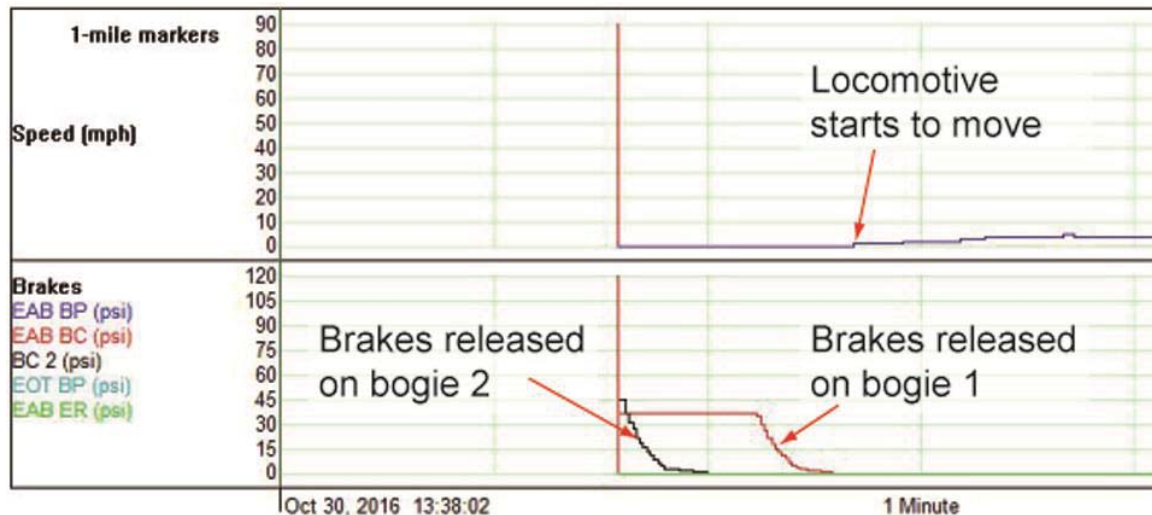
The locomotive's data recorder shows that he isolated bogie 2 first, then bogie 1. The locomotive then ran away on the slight gradient.

Brake pressure and locomotive speed recorded by the locomotive's data recorder

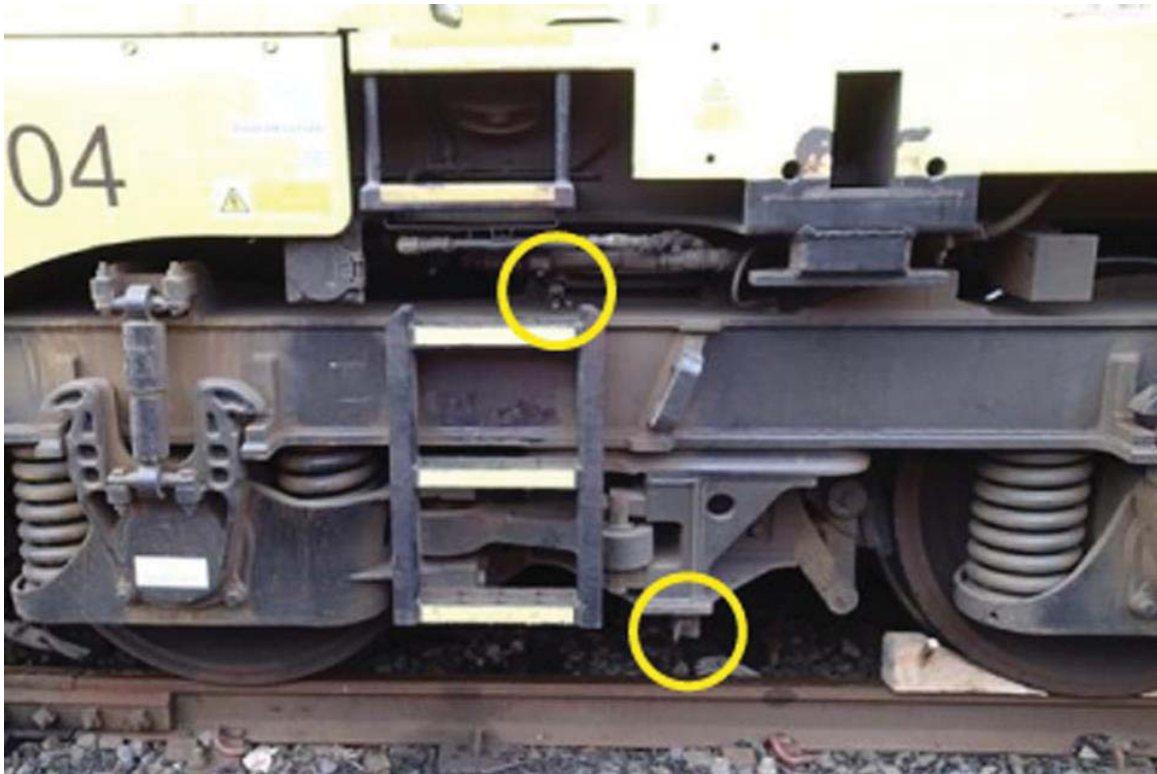
Just prior to the incident, the driver, having dealt with the locomotive at the front of the train, started the engine on locomotive 70804. He then intended to reinstate the parking brakes. However, he was unsure of the correct steps to take and mistakenly operated the bogie isolation valves thereby isolating the service brakes on each bogie in turn. The two bogie brake isolation valves are positioned on the underframe, one above each bogie. They allow part of the compressed air system, in this case the brakes on a bogie, to be isolated. The locomotive manufacturer's operating manual lists 21 such isolation valves in various parts of the air system; these are provided to isolate parts of it in case of faults (eg an air leak).

Location of parking brake isolation handle (circled bottom) and bogie brake isolation valve (circled top)
