## **Liverpool Lime Street cutting retaining wall failure**

**Ref:** NRB 17/06

**Date of issue:** 27/03/2017

**Location:** Liverpool Lime Street

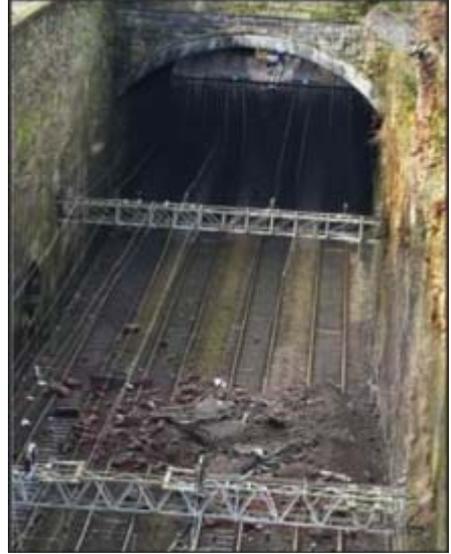
At around 17:45 on Tuesday 28 February 2017, a section of retaining wall at the top of Liverpool Lime Street cutting collapsed resulting in significant debris falling onto the railway below, damaging OLE and obstructing all four running lines.

Photographic and other evidence show modifications to ground levels and changes in land use over recent years adjacent to the retaining wall which appear to have resulted in significant overloading of the wall.

- How effectively does examination of retaining walls consider change in land use or ground level that could lead to overloading?
- How should we identify boundary walls or retaining wall parapets which have become retaining walls through ground level changes?
- How do we check that structure and boundary inspections access areas behind a wall to ensure changes and potential risks can be identified?
- How do we access third party land to undertake compliant inspections?
- How should we ensure land disposal does not impact our ability to access and maintain structures?
- How effectively do we check structures in complex cuttings?
