# Shared Learning

**The Thameslink Programme**

**Issue Number: TLP066 Title: HV Cable Close Call**

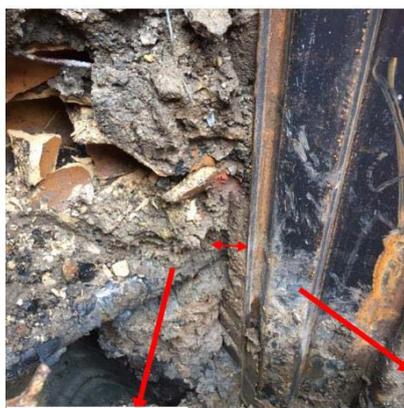
In order to fit the pipe into the sewer the operatives cleared the bottom of the trench. It was during this clearance that the team became aware of the 22kv cable. The cable was approx. 20mm from the edge of the trench sheets that had been installed.

22KV cable found  
Friday 14th Oct

Sheets were  
installed Tuesday  
11<sup>th</sup> Oct

This close call was a combination of systematic failures. The hierarchy for avoiding Underground Services (HSG 47 and Skanska procedure SCE OWOW) was not followed. The incorrect information was given to the team, for what was a heavily congested area thus resulting in the signal from the scanner giving incorrect readings and identifying a cable further away from the one that was almost hit.

- The 22KV (now 11KV) in question may have been masked by the other cables. In congested areas the potential for the signal to jump from one cable to another a common detection problem.

- The permit to dig and CAD drawing indicated an EHV 22KV cable at a depth of 750mm the actual depth of the cable was approx. 2mtrs. (The cable was also in close proximity to the clay ducts containing the two further 11kv cables that were not identified on the cad drawing).

- The site team was briefed on the significant event.
- Training session held on the Safe Systems of Work whilst excavating in or around underground services.
- BDU team re-briefed on the Health and Safety Executive Publication HSG47 following hierarchy of risk control procedures, Skanska Our Way of Working EHS018 Location and Avoidance of Buried Services.
- Team advised that Utility / Service drawings over six months old may not be used as part of the planning or implementation of the works. The most up to date information must be sourced from relevant Stakeholders ie Distribution Network Operator (DNO), Highways Authority, Ministry of Defence and Network Rail.
- Additional training organised for the use of CAT scanners (RD8000) which included all operatives who undertake this task.
