COSTAIN
The Thameslink Programme

Issue Date: 7th June 2017 - For further info contact sharon.fink@networkrail.co.uk

Issue Number: TLP 074
Title: MEWP Wheel Detachment

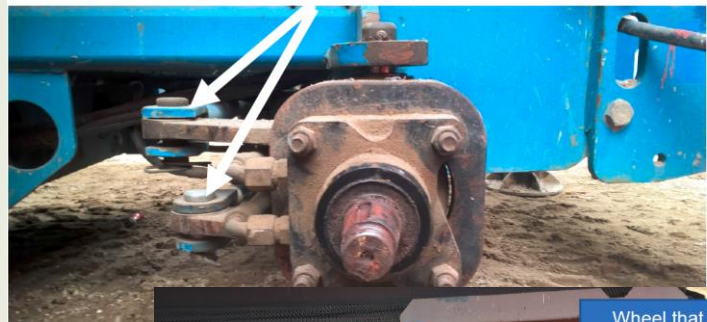
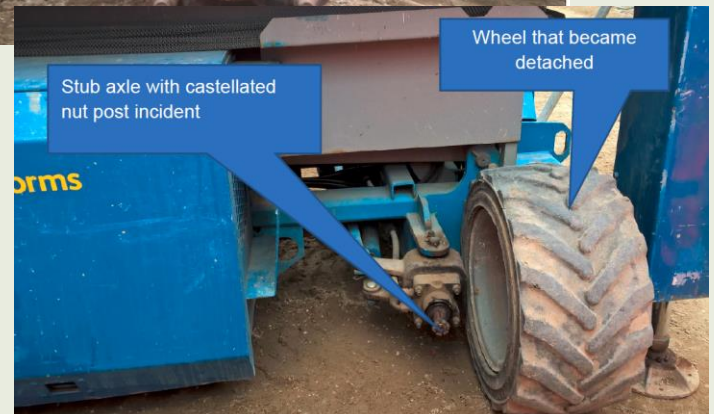
Photo of Event :

Description	Kingpin Assembly Pins x 2 that were Incorrectly Identified During Pre Hire Inspections as Worn and Replaced 3 times
-------------	---

Immediate Cause – The stripping of the threads on the castellated retaining nut allowed the wheel to become detached as the castellated nut failed to hold the wheel on the axle. The retaining plate had become worn from the key/keyway movement on the axle allowing the castellated nut to move the subsequent continual movement clockwise and anti-clockwise caused the stripping of the threads.

- **Maintenance Management:** The engineers completing the pre hire inspections (PHI) did not identify the root cause of the movement identified during the inspection they mistakenly identified the kingpins (a common fault on this type of scissor lift) as the cause of the movement in the wheel/stub axle arrangement.
- **Communication:** There was a failure to adequately identify and question why the kingpins had been replaced 3 times in 6 months or review previous maintenance reports that 3 replacements of the kingpins had been completed.
- **Design:** The castellated nut was not secured with a split pin through the shaft of the stub axle, the design had been changed by the manufacturer Genie/Terex in favour of the fixing plate arrangement.

- Nationwide Technical Bulletin for GS32 & GS26 scissor lifts to check Hub Bolt Torque settings and plate/castellated nut wear. The removal of the hub will include a Woodruff key inspection. Any anomalies they will be replaced / reported.
- Awareness campaign & safety alert on further scrutiny of movement from wheels on scissor lifts and retaining plates for all Nationwide engineers. Information passed to Genie/Terex.
- The Nationwide computerised maintenance system is being assessed to ascertain if alerts can be set up when items such as kingpins are replaced out of scheduled times to help highlight a deeper issue.
- The retaining plate was a design change from the manufacturers Genie/Terex from the original split pin design. To be assessed post incident and split pins should be replaced as a further measure to prevent a reoccurrence.
