# Shared Learning

**The Thameslink Programme**

**Issue Number: TLP078 Title: Lifting Anchor Failure**

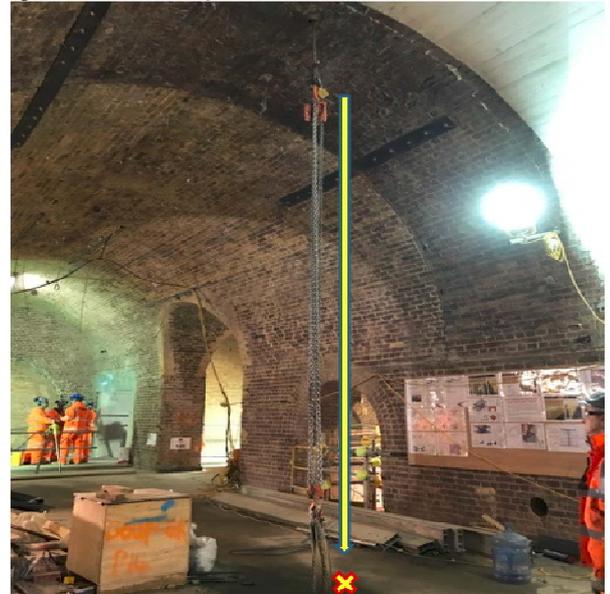
A set of 3t chain blocks and a 1.0m length of 20mm diameter Dywidag bar fell from a height of 5 metres (see Fig 1 below). No one was struck or otherwise injured. The lifting tackle (chain blocks) was suspended from a hook attached to a lifting anchor (a Dywidag bar system that involved the joining of 2No. bars together using a proprietary coupler in accordance with an approved design). The top of the Dywidag bar is cast into a concrete slab above the arch. The chain blocks are 1 of 4 sets of lifting tackle used to lift the shutters for the quadripartite arches. The lifting operation had been completed and the blocks were not being used to lift at the time that they fell.

Fig. 1 Chain blocks were in this position

**Immediate Cause** – the bottom length of Dywidag bar unscrewed from the top length causing the bottom bar and attached lifting tackle to fall. **Underlying Causes** :

- Brief to team that only CREs to administer changes and must be formally agreed in writing. The Just & Fair Culture process will be used if process is not followed.
- The Risk Readiness Reviews (RRR) agenda has been revised with experienced people in attendance.
- A prohibition on interim design (non-AFC) drawings
- Temporary works design to be included in the 'permission to commence construction' process
- System developed to introduce a design hold point system (reference in design drawings and ITP)
- Design & installation check points included in temporary works drawings
- Temporary works design to be in place and fully signed off preceding submission of WPP for acceptance (WPP to include references to design)
- Permit to load process reviewed
- A site wide communication was issued to raise profile of risks associated with lifting or load left suspended
