MEWP basket failure – RIDDOR dangerous occurrence

Ref: NRL 17/03

Date of issue: 08/09/2017

Location: Cowlairs

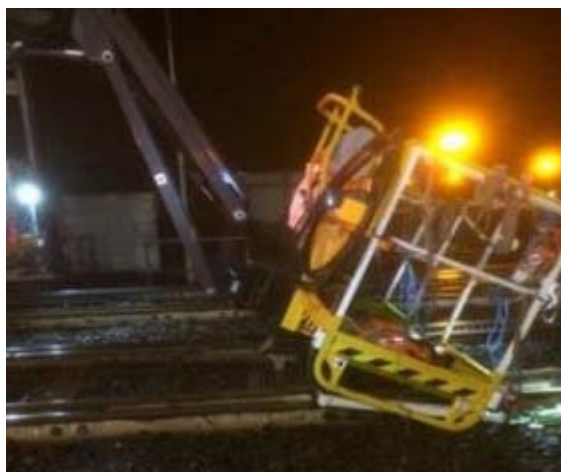
On 3 March 2017 a Road Rail Mobile Elevated Work Platform (MEWP) accessed the track to undertake installation work. While waiting for instruction to pass a set of points the boom holding the basket sheared and the basket holding an operator fell to the ground.

The basket was approximately 50cm from the ground when it tipped over and struck the ground settling at a 35° angle. The operative was uninjured.

On examination after the failure, the basket end pin of the fly jib cylinder was bent sufficiently to cause a fatigue failure in the rotator bracket that connects the basket to the fly jib. Two or three months passed between the initial damage and the failure.

- Impact damage to the MEWP basket is believed to have been caused by a collision whilst stabled in the compound.
- The damage indicates that the MEWP was stabled with the basket in a lowered position.
- The collision was not reported.
- Observable damage was reported / logged but not investigated or acted upon with a repair.
- Recording visible damage discontinued even though the damage had not been subject to further investigation e.g. non-destructive testing.

- Create designated areas for MEWPs in compounds and depots. Discuss the methods that will protect this type of plant from collision.
- Wherever possible stable MEWP baskets in the elevated position when not in use.
- All plant movements in compounds must be controlled by a banksman. Attention must be given to how this is achieved for shared compounds.
- Systems are required to facilitate the reporting of collision and / or damage to plant.
- The process for responding to / rectifying damaged plant in depots and compounds needs to be clear and checked to make sure it is effective.
