Infrastructure Projects Shared Learning

Issue 17/01: January – June 2017

This Shared Learning document details key issues and incidents that have occurred on Signalling Projects between January and June 2017; and provides the key learning points associated with them.

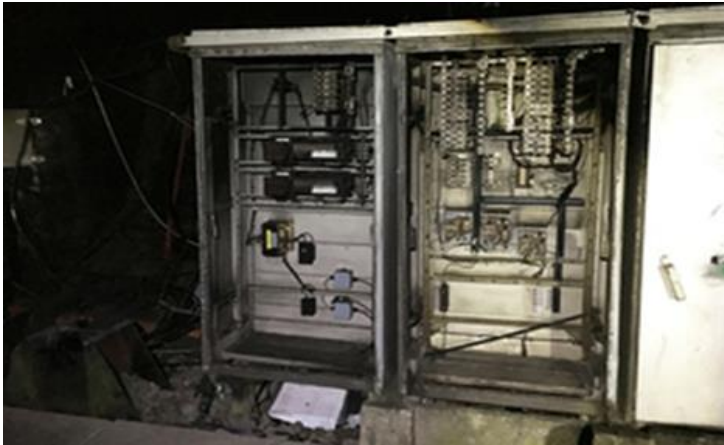
Equipment left unsecured

Two trains struck redundant Western Region style location case lift off doors that had been left unsecured and were drawn towards the track by aerodynamic effects of passing trains.

The 221 padlocks, which were an integral part of the door design, such that handles need to be padlocked to stop them falling to the open position, had been removed as part of the project's recovery work.

One train suffered a damaged TPWS aerial, which was not identified until the next TPWS power up test of that cab. The affected train was protected by GW ATP during the time that it was running without operational TPWS.

Comply with the rules for securing doors of location cabinets when work has been completed, and check them before confirming that lines are safe and clear for the passage of trains.

Introduce control measures during the planning of works to reduce the risks associated with unsecured location cabinet doors during or after decommissioning of the cabinets.

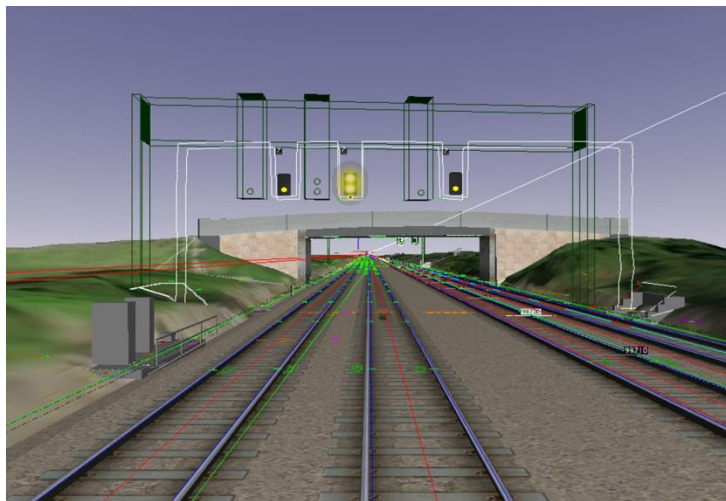
In the example below, the position of the signal gantry was incorrect in the model, so when the OLE stanchions were constructed on site, they obscured the signal aspects.

Green is original CAD model. White is actual position.

However, always ensure that the details are input accurately and the model is kept up to date by all parties.

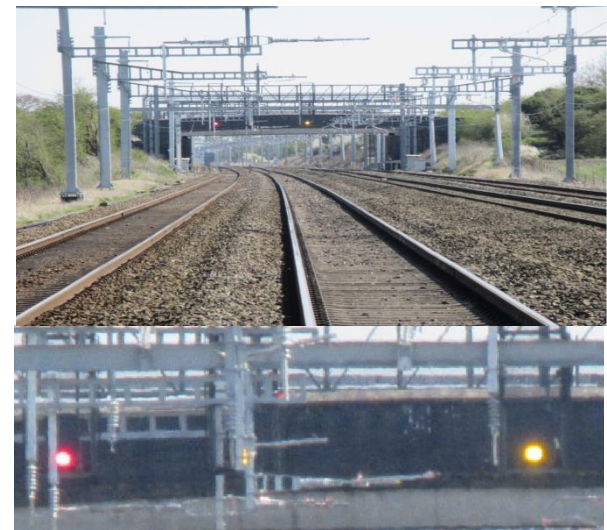
LX Obscured by Incorrectly located OLE

OLE foundation installation was carried out 'At risk' prior to the IDC/IDR taking place.

Impact on LX sightlines was identified during IDC/IDR of the OLE steelwork

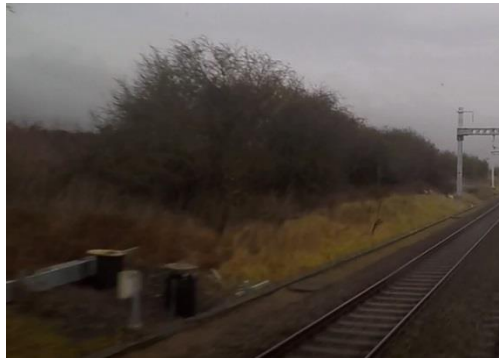
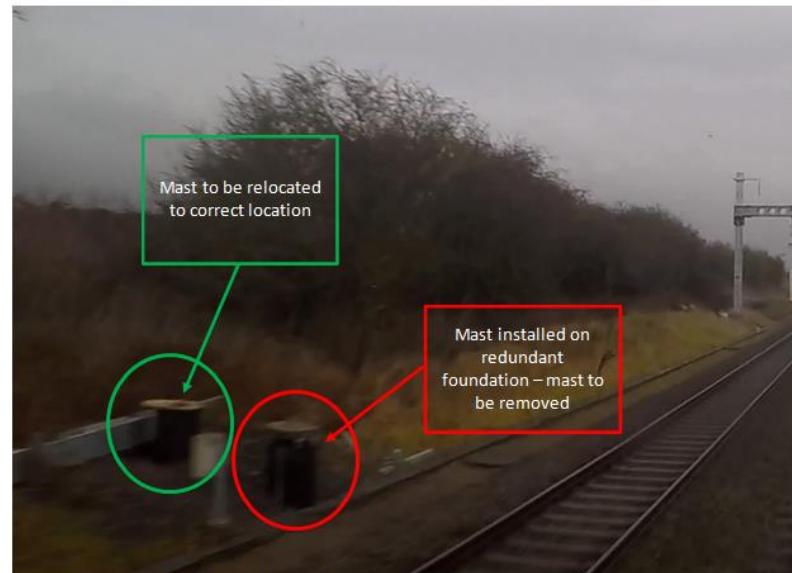
Figure 1 Structure location 00/200112 - 400m from crossing

A revised OLE foundation position was agreed and a new foundation installed.

However, the OLE mast was then installed on original (incorrect) foundation.

Always ensure that that any installation not intended for use is clearly marked, capped, or shielded (as appropriate) until such time that it can be recovered.

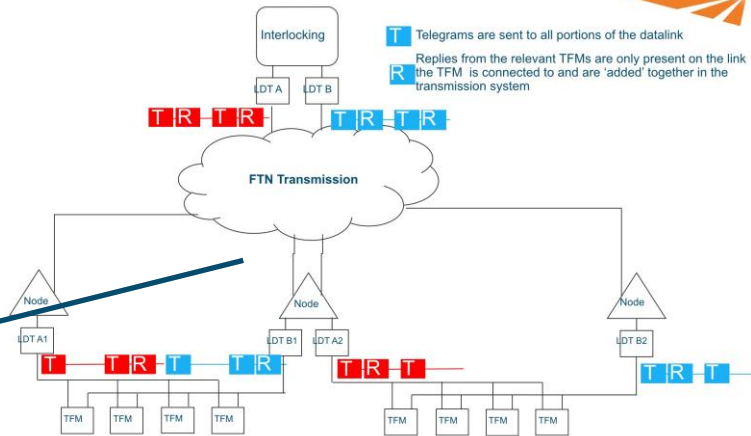
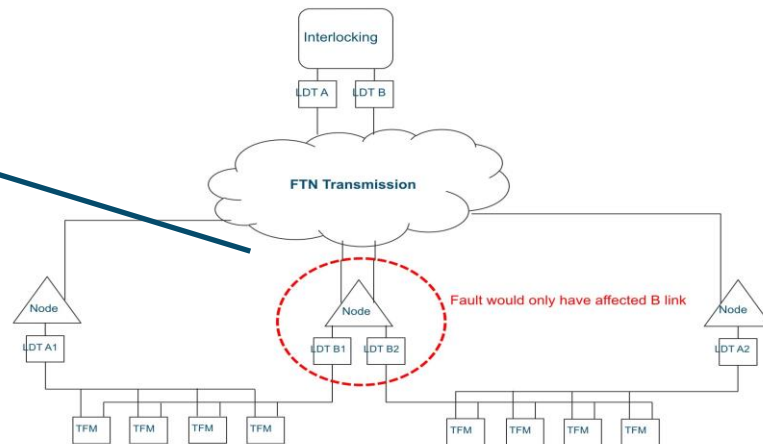
SSI Datalink Diversity in FTN

A & B links through one node (diversity in that they are also through two other nodes).

Noise applied on the transmission by this node affects BOTH links.

Could be averted by having either two nodes OR both A legs or both B legs through the single node.

Issue can be avoided by defining this as a requirement in the project requirements documentation and ensuring an understanding of the full system architecture.

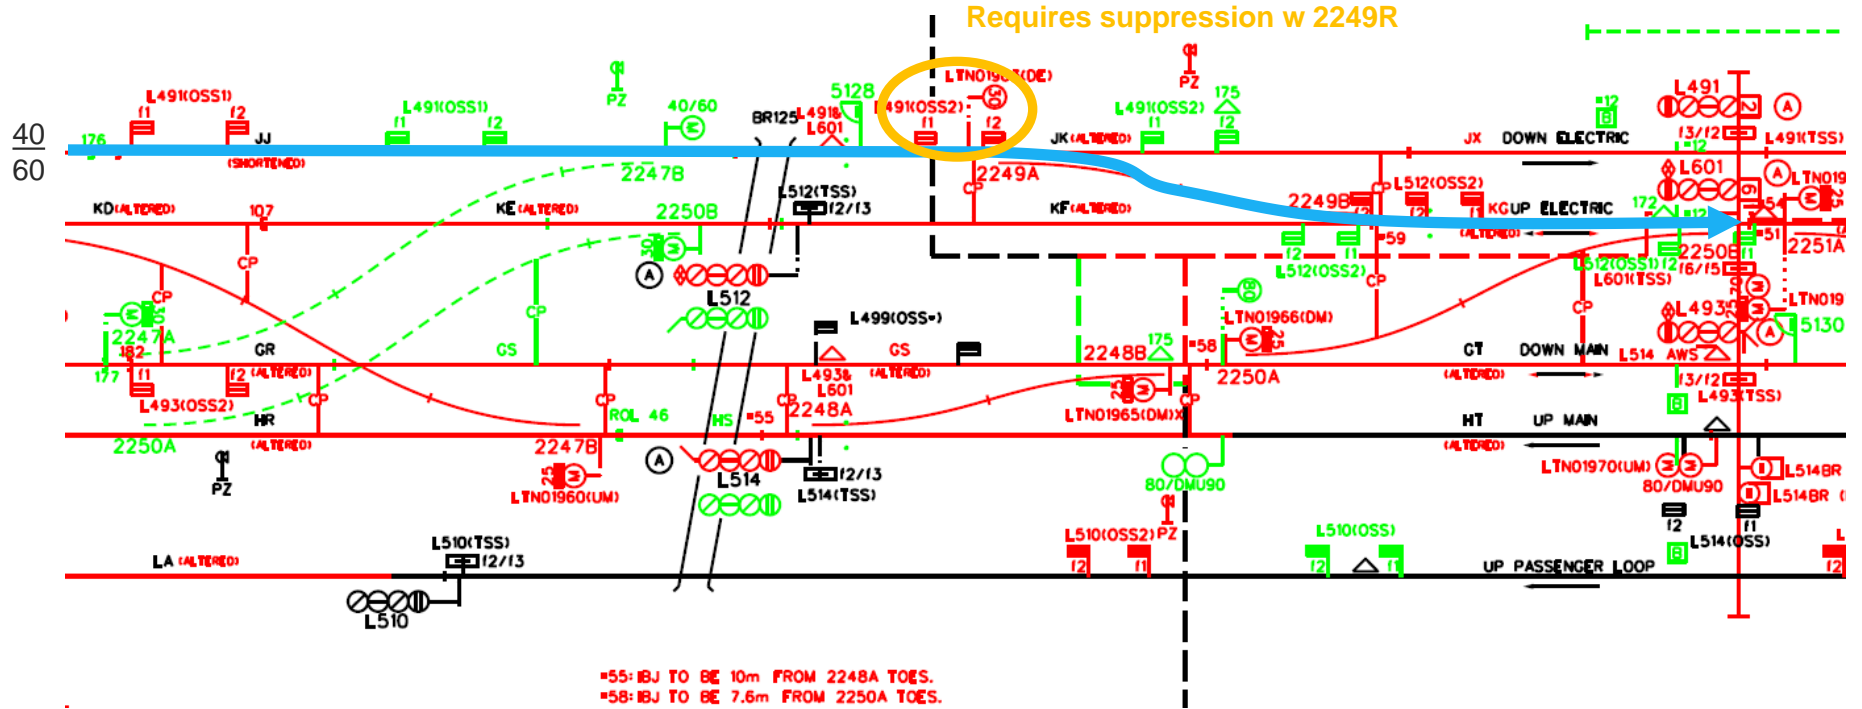
TPWS Complex Approach

Freight trains through 2249 points reverse were getting TPWS activation due to suppression on the OSS not being provided.

Generally, a diverging approach will require OSS suppression for any OSS that could be passed over by a train while not approaching the signal controlling the OSS in question.

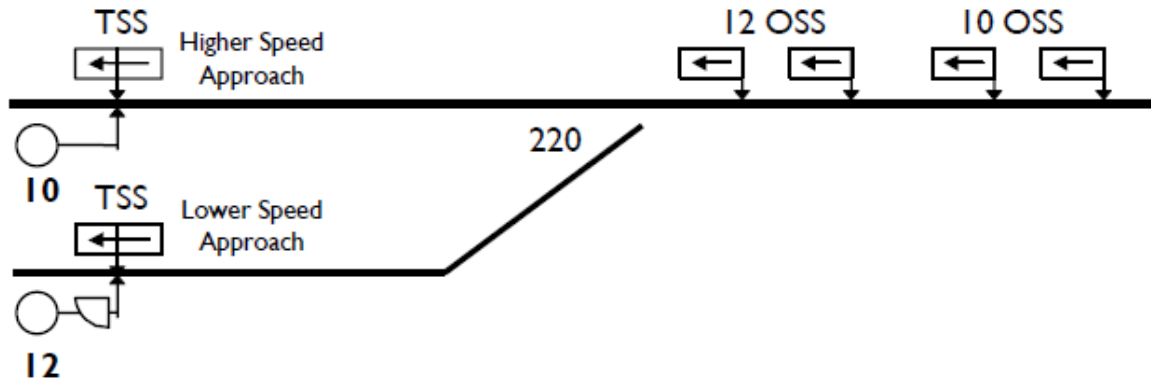
10.7 Example 1 - Diverging Approach – Separate OSS

However, a train approach 10 signal at proceed when 2 signal is at danger is going to get tripped by 12 OSS unless the attainable speed at 12 OSS is lower than its set speed. This would create a requirement for lengthy braking curve calculations, hence it is simpler to design such that all diverging approaches require OSS suppression irrespective of the differential speeds and positions of signals on the diverging routes.

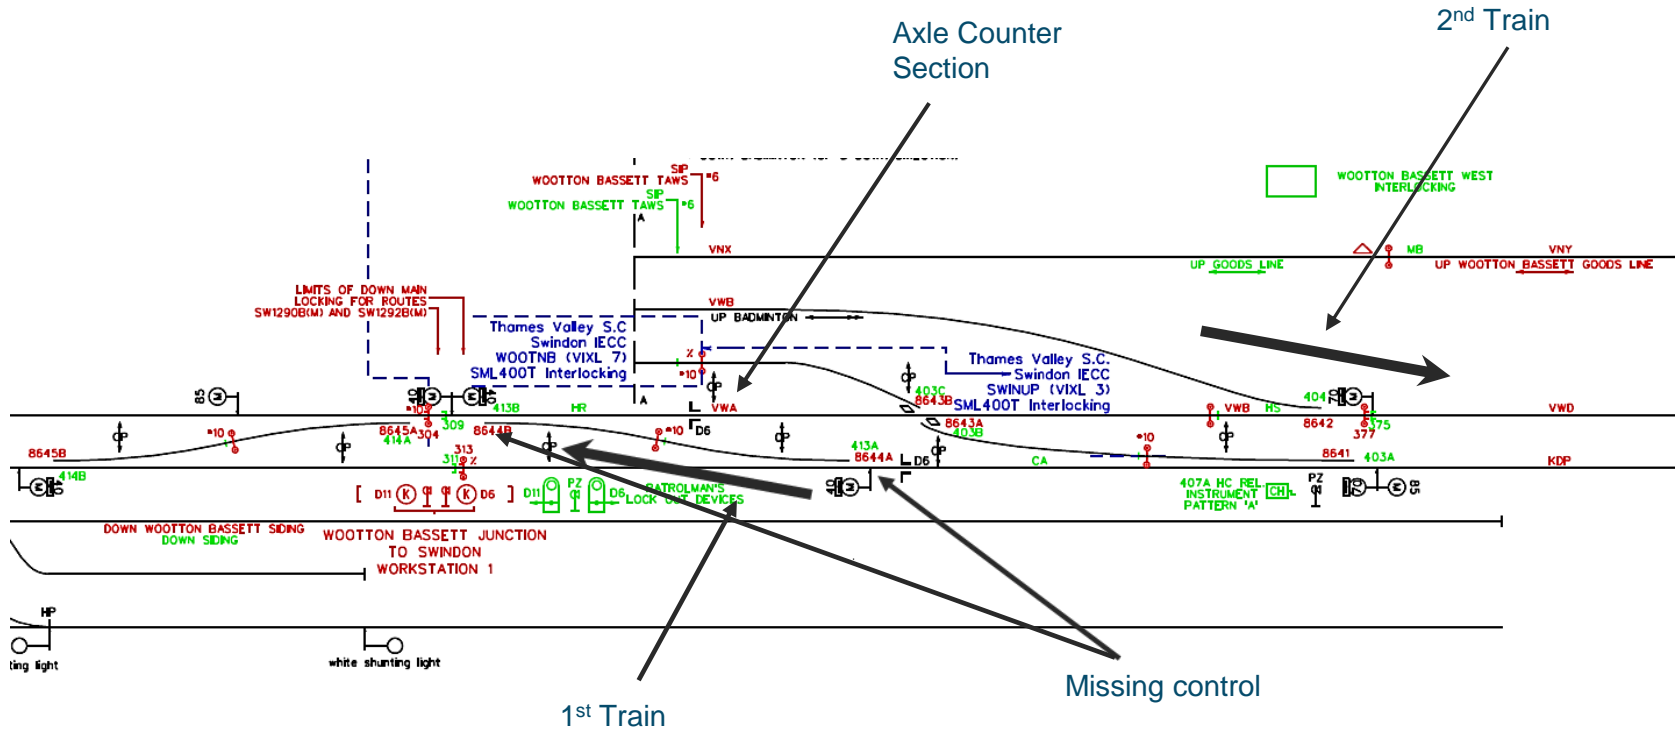
Control Tables: Missing Aspect Control

A signal changed from green to red in front of a driver whilst a valid parallel move was taking place, due to a missing aspect control. The existing control table had this control to allow such parallel moves to take place. This was not replicated in the new control tables.

When re-writing control tables, always ensure that a review of the existing controls is undertaken to ensure any unusual or novel controls are identified and assessed for inclusion within the new interlocking.

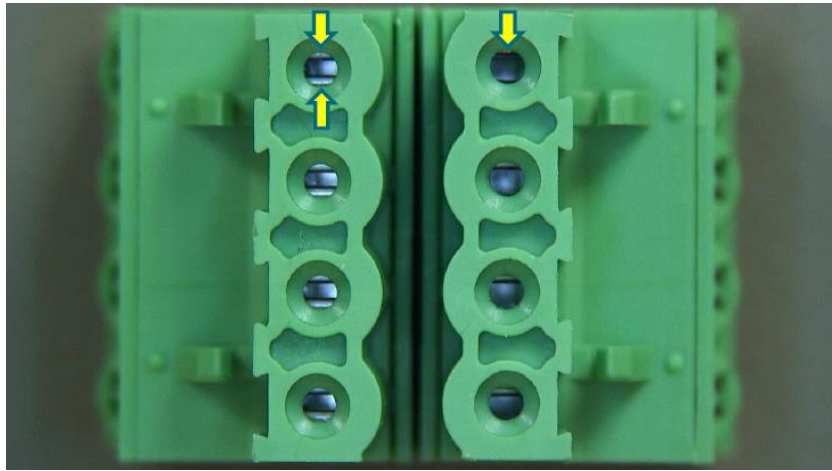
Damaged Plug Coupler

New: Both Contact Springs are Visible. **Faulty:** Only one contact spring is visible

During testing of a cable via a plug coupler, the plug coupler has become damaged causing either intermittent or no connection.

When bell testing, never do anything to expand the connectors i.e. inserting a probe. Always;

- ▶ Bell test to the screw terminal, or in its absence to the test points.
- ▶ Where the above is not feasible, a mating connector must be fitted and tested accordingly.

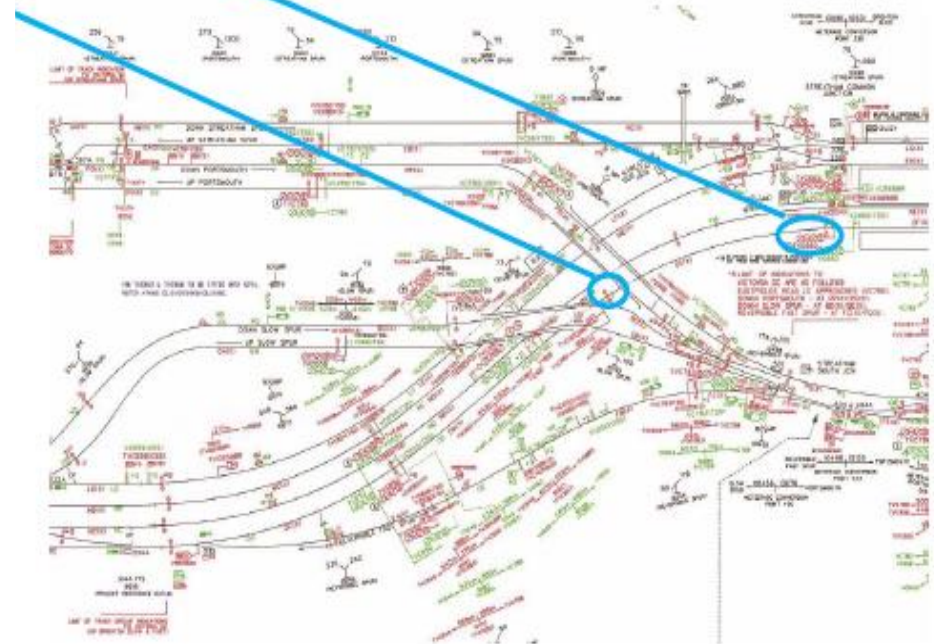
Scheme Plan Clarity

A separate overlap track on an auto-signal, missing from a commissioned interlocking, manifested itself as a result of being omitted from the control tables. The error in the control tables was not spotted during the checking, data design or testing processes, with the issue being identified by the signaller.

Although this was a very simple arrangement and control, the presentation of the information on the scheme plan appears to have contributed to the overlap control being missed.

Designers are required to think about the end user of their designs to ensure the information they are presenting is as clear as possible. Where appropriate recoveries should be put on a different level in the design, so “red only” copies can be produced for interlocking designers.

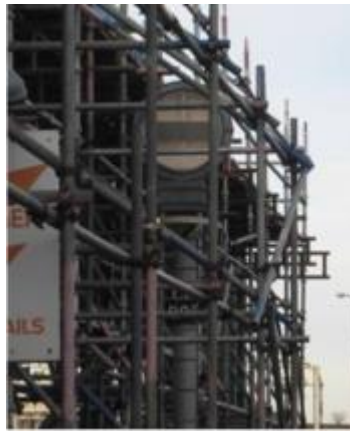
Can you see the banner repeater?

The impact of both construction work and the final equipment arrangement should be assessed as part of the design stages and considered in the IDC (Inter-Disciplinary Check) process to ensure it meets the needs of the end user, doesn't impact operational performance, or introduce unacceptable safety risk.

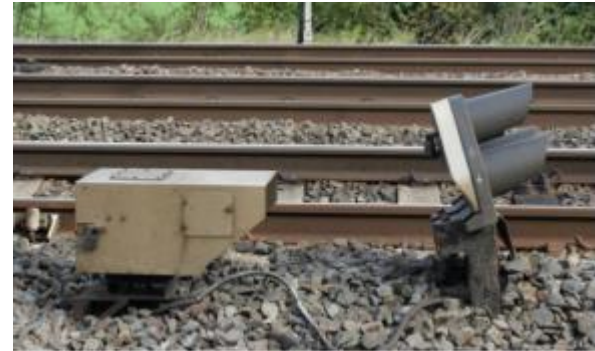
Reading the route indicator may be a problem

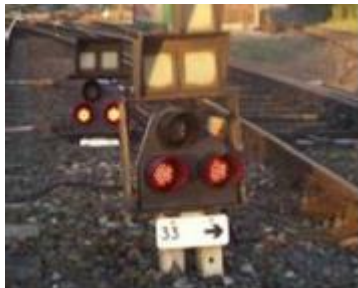
Not ideal positioning

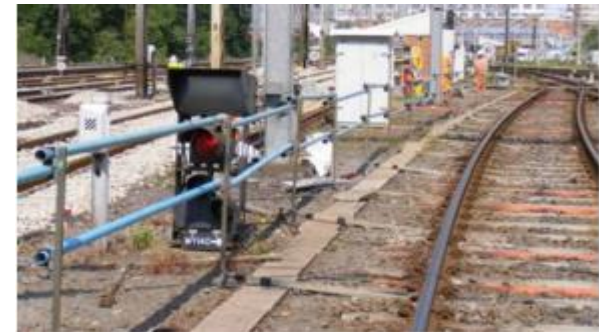
Temporary fence obstructing signal
