Failure of Tensorex C+ upper fitting bracket in OLE

Ref: NRA 17/10

Location: Structure MLN/46/424, Great Western Main Line

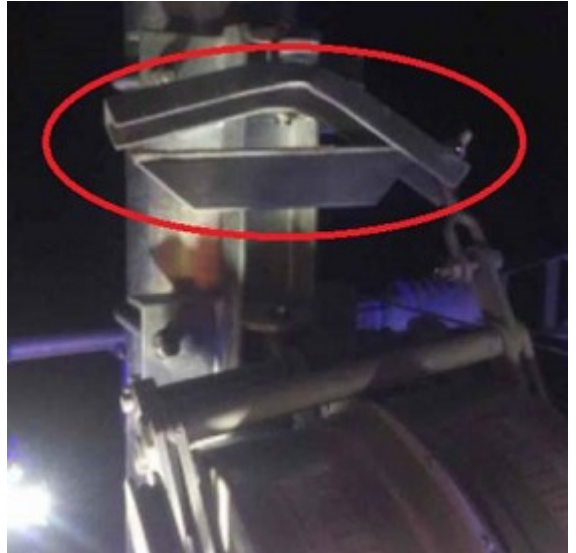
On the evening of 28 August 2017 the failure of a Tensorex Upper Fitting Bracket (Pfisterer part number 042216) was discovered in the Overhead Line Equipment (OLE).

Investigations indicate that the failure of the bracket was caused by poor quality welding of the stiffening plate during manufacture. This in turn caused a secondary failure of an M14 terminal fork.

1. identify all locations where they are installed;
2. inspect all installed brackets; and
3. check all brackets in stores for poor quality welding.

The inspection should focus on the quality of the welds, damage to the weld and insufficient welding of the stiffening plate.

Any unit which has been fitted with the 042216 upper fitting bracket, and has subsequently failed the visual inspection should be retrofitted with a replacement part fully compliant to the design specification at the earliest possible opportunity.
