## Overheating on Bussman Cam Master fuse holders used to replace Red Spot fuse holders

**Ref:** NRA 18/01

**Date of issue:** 16/01/2018

**Location:** Wyke Cop, LNW

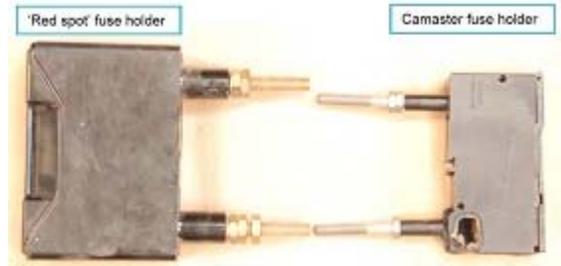
Distortion caused by incorrect fitting of a Bussman fuse is likely to have caused the insulation on the holder to fail, creating both localised burning and a fault to its supporting metal plate. This fault could create a touch voltage above 60V on the supporting metal plate.

The technical investigation into the failure of the burnt out Bussman Cam Master fuse holder showed that at some time earlier it had been used to replace a Red Spot fuse holder.

The photograph above clearly shows that the spacing between the connecting studs is very different on these two types of fuse holder.

The Bussman fuse holder had been fitted to the metal plate which had been previously drilled to accept the Red Spot fuse holder and it can be seen that the Bussman fuse holder connecting studs were splayed-out to fit.

- When accessing signalling power distribution equipment operating above 175V, members of staff and contractors must use procedure NR/SPS/S004 (see NR/L3/SIGELP/50002) to test for touch voltage on:
  1. metal covers on signalling power distribution equipment AND
  2. the metal plate on which Bussman fuse holders are mounted.
- The practice of direct replacement of Red Spot fuse holders for Cam Master fuse holders is prohibited without a mounting hole adjustment.
- Existing maintenance interventions and work instructions are being reviewed and amended to identify this potential defect.
