Shared Learning

The Thameslink Programme

Issue Number: TLP083

Title: Cable Drum Spindle Fall into Public Area

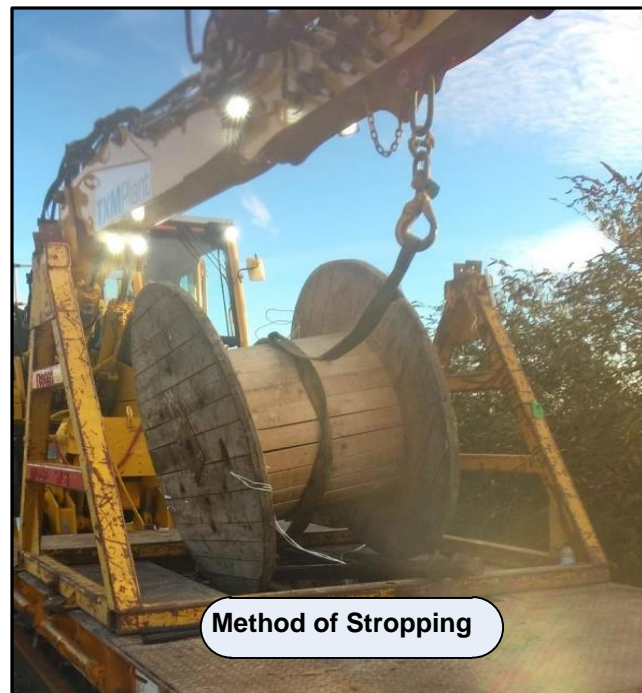
Method of Stropping

- The drum was incorrectly slung with a single Strop allowing it to tilt.
- Lack of competence/experience of the team in lifting cable drums.
- Cable drums had been stored on their sides on the trailer.

- Communication issued to the project/supply chain that lifting must be carried out in accordance with the Principal Contractor 'Lifting operations: Our Expectations' process.
- Going forward, diagrams/instructions to be included in cable drum Lift Plans, including stropping arrangements.
- Safety Bulletin issued – 'Lifting of cable drums on bridges and the correct procedure for lifting, including the prohibition of lifting on viaducts /under bridges without a detailed Risk Assessment'.
- Project instructed to place all cable drums into the correct storage position on their rims.
- Mandate and train supervisors in the use of Lift Plan assessment sheets and POWRA (point of work risk assessment).
- Re-training and assessment of the Crane controller involved in the incident, followed by a period of mentoring.

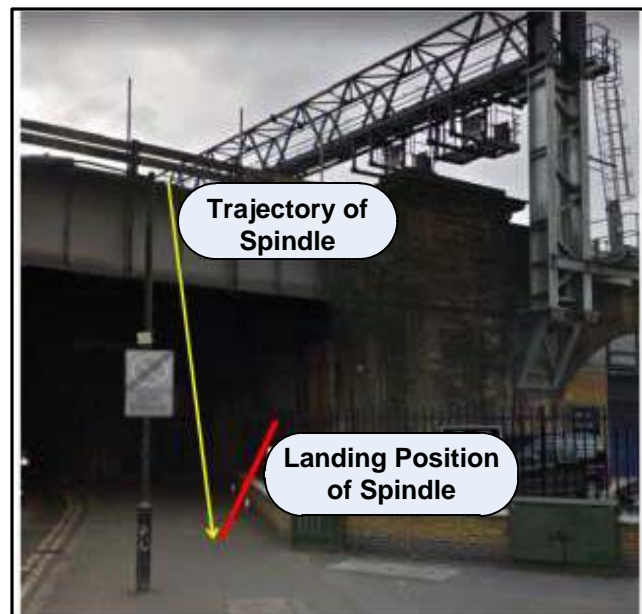
On 19th November 2017 at 13:00hrs, a track team was lifting an empty cable drum from an 'A' Frame mounted on a track trailer. During the lift, the cable drum spindle bar snagged on the 'A' frame. On further attempting to lift, the drum jerked and tilted causing the spindle bar to slide from the centre of the drum. The spindle bar fell through a gap in the parapet wall approximately 8m to the ground below, into a public area.

Trajectory of Spindle

Landing Position of Spindle
