## Derailment of passenger train

**Ref:** NRB 18/03

**Date of issue:** 09/02/2018

**Location:** Loch Eilt, Scotland

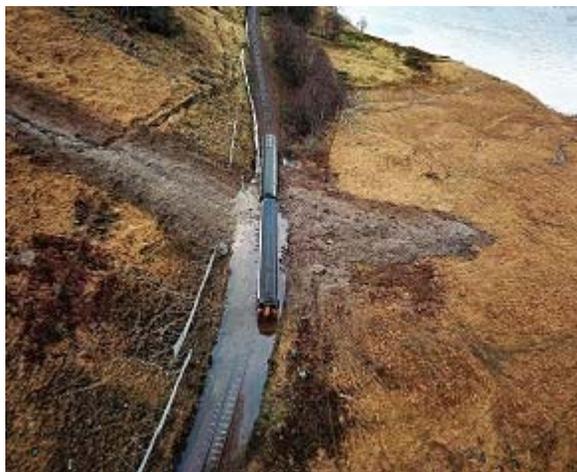
At 06:47 at Loch Eilt near Arisaig the 06:03 Mallaig to Glasgow Queen Street train struck the debris from a landslip and became derailed.

This failure appears to be a moderate to large debris flow (as much as 400m<sup>3</sup>) that commenced in excess of 50m beyond the railway boundary. The location does not coincide with any previously known deep gully features, although there may now be one formed by this event.

The location was included in the 2016 engineering work and rockfall was deemed to be the greatest risk. Rockfall barriers (catch fences) were installed. These were designed to prevent individual boulders from reaching the track and were not intended to prevent a debris flow such as this. They may have helped to disrupt or slow the initial flow but would quickly have been overwhelmed.

The cause of the slip is likely to be saturation of the soil overburden. The 24 hour rainfall total was circa 20mm which is unlikely to be sufficient on its own to cause the event but a rapid temperature rise will have contributed to snow melt and sudden release of water from the hillside. RAIB has identified the combination of rain and melting snow as a factor to explore in its investigation.
