Train strikes rail at Cradlehall on the Highland Mainline

Ref: NRB 18/05

Location: Cradlehall, Highland Mainline

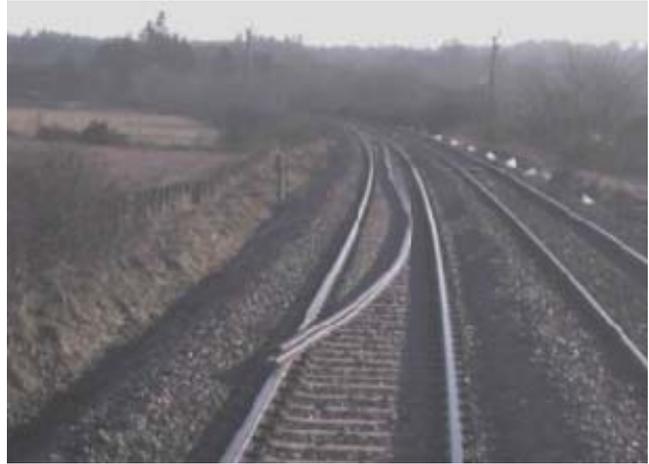
Footage from train mounted FFCCTV

On 25 February, the 09:40hrs Inverness - London Kings Cross Virgin Trains East Coast service, that was the first train after a possession, struck a length of rail which had been left resting on the head of the cess rail.

The train struck the rail at 53mph and forced the 425ft length of rail into the cess. The train did not derail and damage to the rolling stock was confined to the lifeguard on the leading bogie.

The northern end of the rail was inadvertently left sitting on top of the up cess running rail. This error remained undetected until the passenger train hit the rail.
