# Safety Bulletin

## Mobile elevating work platform (MEWP) collision

Ref: NRB20-02

Location: SSV Rochford - OLE Renewals

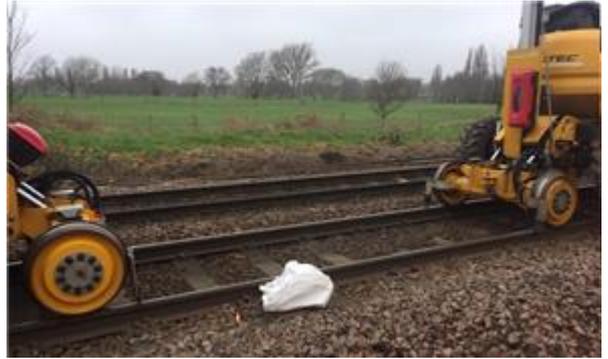
Whilst renewing Overhead Lines at around 11 am on 25/01/2020 two Skyrailer MEWPs collided.

One MEWP was travelling on the Down Road towards a second stationary MEWP also on the Down Road.

The Machine Operator in the travelling MEWP was unable to slow the machine on approach to the stationary MEWP leading to a collision.

Two Overhead Line Persons were stood in the stationary MEWP basket. On collision they were thrown within the basket. Both people were correctly clipped into the MEWP basket at the time of impact, and remained in the basket.

Think RISK and "Take 5" before work commences and during the work. If there are changes to the planned OTP work these should be approved by the POS representative who must document any changes and ensure they are communicated and understood.
