On track plant derailment at Worcester

Ref: NRL20-06

Date of issue: 08/06/2020

Location: Wales and Western

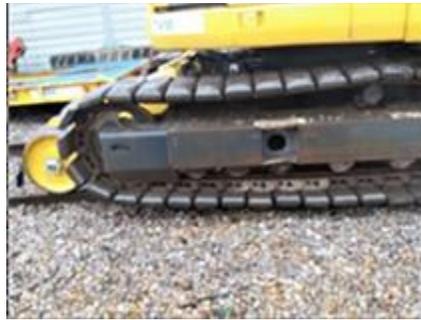
On the 25th November 2019 a Komatsu PC138 Road Rail Vehicle (RRV) derailed whilst lifting a 20ft track panel and travelling over a set of points at Worcester Shrub Hill station sidings. This caused damage to baseplates and securing bolts. The derailment category was classed as moderate to severe.

At the point of derailment, the RRV was travelling in an unsafe mode due to a fault in the axle control system. This fault was known to exist by the Machine Operator (MO) and was being exploited to achieve a perceived increase in stability. This action was in contravention to the machine operating instructions and the MOs competence.

The fault permitted the machine to travel without the rail axles being fully deployed and had also locked the axles thereby preventing machine compensation for poor rail geometry. The MO carried out the lift operation with the Rated Capacity Indicator (RCI) in a non-lifting mode so it had no visible or audible warning of the limit of the machine's safe lifting capacity.

Operating the RRV in an unsafe mode with the rail axles not fully deployed, rail axles locked and the RCI being in a non-lifting mode, were the significant immediate causes of the derailment.

- All machine faults and defects must be reported and recorded in accordance with company procedures.
- Safety-related plant defects must be reported using NIR-Online and in accordance with RIS-8250-RST.

- RRV's must be operated in accordance with the machine operating instructions and the competence requirements.
- The correct lifting mode must be selected on the RCI before the machine carries out any lifting activity.
