# Water Pollution & Flooding Events

Learning from Events Week

Recent Environmental Incidents – Sharing Lessons Learnt

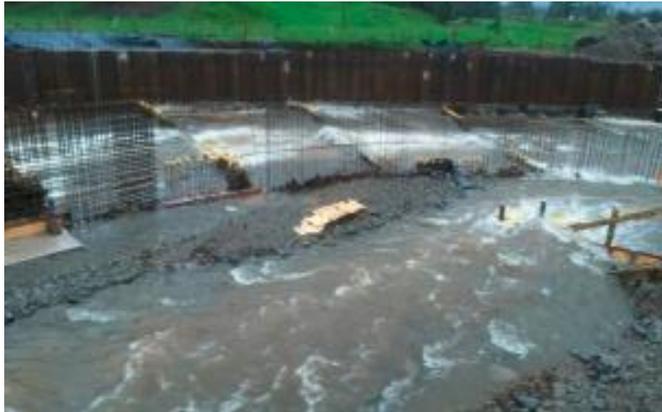
The temporary dam at diversionary channel was overtopped, which resulted in flooding of worksite in the permanent channel

**What Happened:** During works in the River Wamphray, the worksite flooded due to overtopping following severe rainfall, which resulted in down stream silt pollution and damage to the site and riverbanks.

SEPA issued a warning letter for a breach of the site CAR<sup>1</sup> Licence conditions; namely not informing SEPA about an incident (flood event) and failure to control transport of sediment downstream

**Why it Happened:** The temporary diversion channel was insufficient to cope with the increased flow & the project team were not aware of the reporting requirement. Original negotiations occurred over a protracted time to meet SEPA & the WFD<sup>2</sup> requirements

**Shared learning:** Sites at risk of flooding should sign up to the SEPA / EA flood line; &, when working in rivers, consider damming off in small sections only; &, ensure awareness of reporting requirements

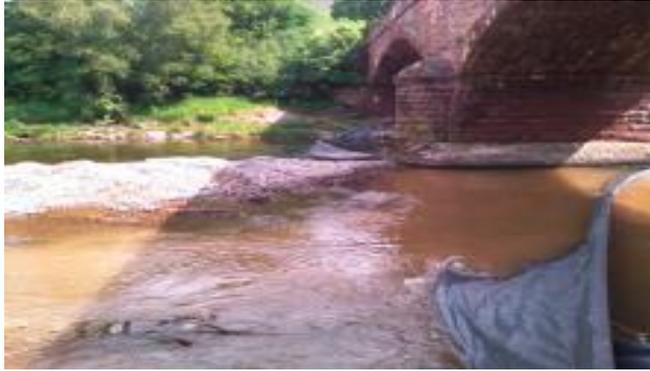
Works were halted but newly implemented mitigation measures at site and downstream were unable to contain sediment

**What Happened:** SEPA received repeated complaints from different 3<sup>rd</sup> parties, of sediment & silt pollution downstream from the worksite which resulted in a number of site visits & several interventions by SEPA. Following these informal warnings, SEPA issued a warning letter for breach of the site CAR Licence conditions

**Why it Happened:** Failure to select BPEO<sup>3</sup> at initial planning stage.

Significant measures were installed but were unable to prevent silt transportation downstream, & failure to monitor the mitigation / pollution & to stop work / report impacts required in CAR Licence

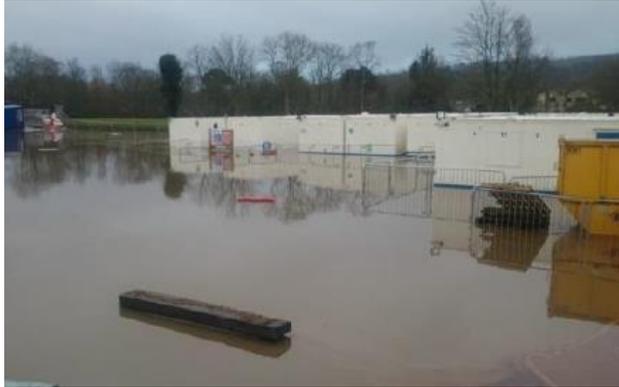
Polluted water contained within the site compound was now hazardous waste

**What Happened** : A compound at Warden Bridge was inundated by water & levels rose to 1.5 metres high within the site cabins. Significant damage occurred to site infrastructure (welfare/offices, etc.)

Paperwork & hardware was lost along with company & personal equipment. A fuel bowser was over turned with up to 4k litres spill estimated & septic waste was included in the mix

**Why it Happened**: Site location was selected due to need for proximity to the bridge & anticipated protection from the existing flood defences.

The existing flood defences contained the contaminated water within the compound footprint which minimised damage to the water environment. The water was now classed as hazardous waste & was cleared by vactor units. The soil was extensively sampled & results shared

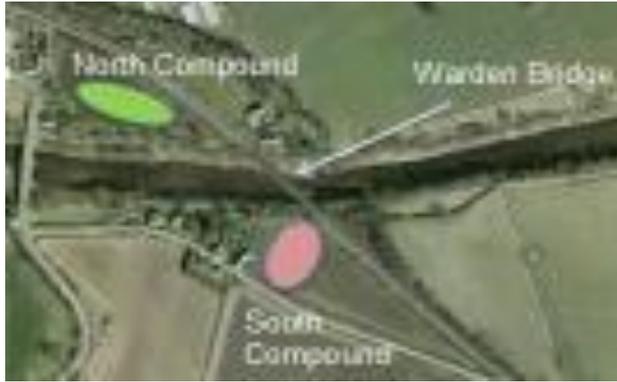
Locations of site compounds relative to the bridge demonstrate why these needed to remain in existing proximity

**Event Learning:** Moving the compounds location was not a practical option for the project due to need for access and type of supporting plant required to carry out the work activities

A risk of flooding recurrence remained and this had to be managed

- Double stacking of accommodation in the main compound meant that key site documentation & records along with technical, office & IT equipment could be stored well above any possible flood peak level.
- A concrete raft & bowser restraint foundation allowed for straps to be attached to the tank reduce risk of recurrence of spill
- The fuel breather pipes were extended to a height above likely future floodwater levels.

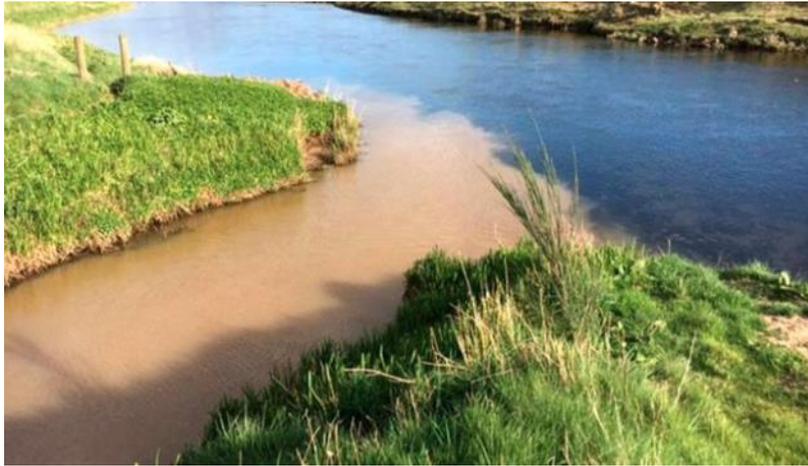
Lessons from other Linear Infrastructure Sectors, include pollution event at AWPR (Aberdeen Western Peripheral Route)

Pollution event resulted in a £280,000 remediation compensation undertaking

- No Cofferdam or protection upstream
- Excessive amount of silt washed downstream of silt curtains,
- No CAR license on site (Required)
- Limited key documentation available
- Significant amounts of waste and detritus in water and no skips or waste management on site

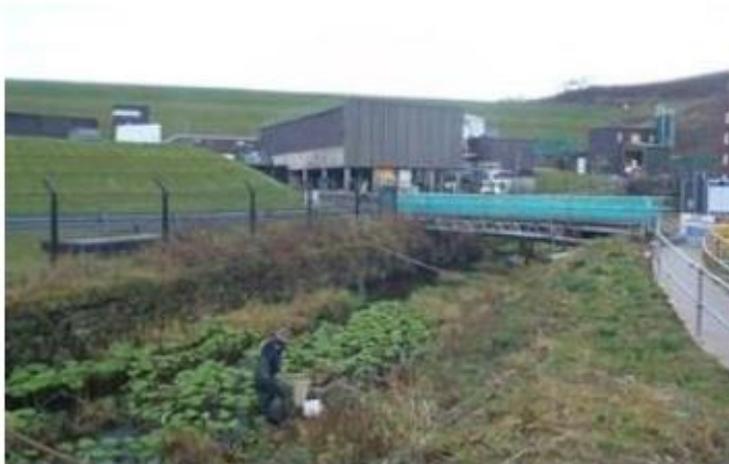
United Utilities Water Limited (UU) has been fined £600,000 and its contractor, KMI+ £333,000 at Bolton Crown Court after pleading guilty to polluting a brook.

The court heard how KMI+ was contracted by UU to carry out improvement works at Wayoh water treatment works at Turton Bottoms. In December 2013, as part of the works, KMI + emptied and removed a tank which had been used to store sodium hypochlorite in 10% solution. Sodium hypochlorite is used in the water purification process and is also the principle ingredient of household bleach. It is very corrosive and is highly toxic to aquatic organisms.
