Safety Advice

Camera mast winch failure

Ref: NRA21-03

Location: Rigton CCTV level crossing

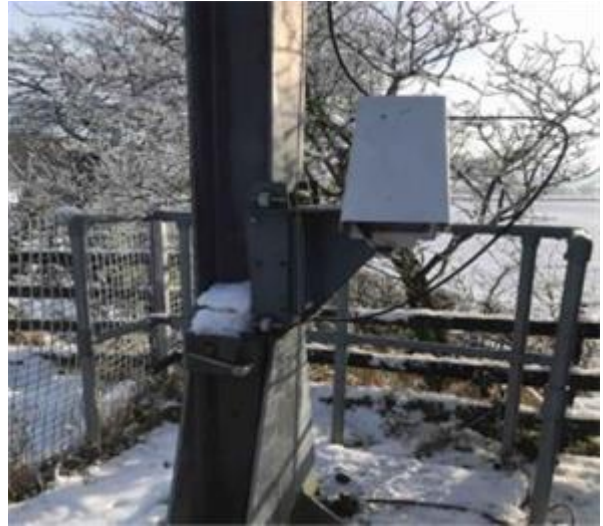
On 15th January 2021, a CCTV camera platform fell down a mast, narrowly avoiding injury to a signalling technician at Rigton CCTV level crossing.

The initial findings are that a component failure within the winch mechanism failed, resulting in the camera platform rapidly descending the mast. It struck the signalling technician's helmet with a glancing blow.

The CCTV platform winch has an emergency brake mechanism intended to prevent this type of incident. However it is believed ice and snow led to the failure. A full review of the equipment is underway.

- Never lower CCTV cameras without the presence of plant technicians.
- If a single camera should fail, the second camera shall be used and a fault raised with the relevant plant team.
- If both cameras fail, escalate the fault level. Plant staff must be present before either camera is lowered.
- Maintenance staff operating the winch to lower the camera shall ensure they are in a safe position and there are no other people in the work area below the camera platform.
- These are interim measures until a full review of this type of winch gear is concluded.
