Failure of small core (16mm diameter) WT Henley Polymeric Insulator

Ref: Local Safety Advice NRA21-02

Date of issue: 30/07/2021

Location: Chiltern Green, East Midlands

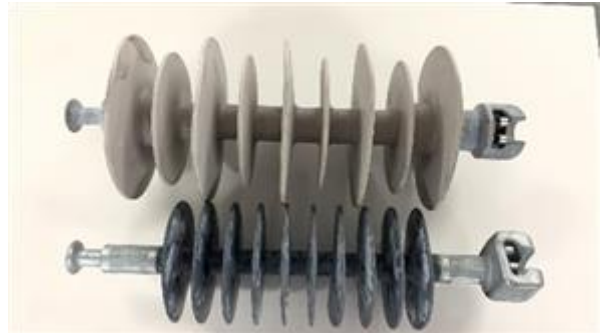
On the 4th July 2021 an OLE insulator parted at Harpenden (Chiltern Green on East Midlands Route). OLE Maintenance staff were adjusting the balance weight pulley wheel separation and had applied lifting equipment "a rig" around the compensating plate between the anchor tail wire and the contact/catenary conductors.

When they released the tension after completion of works, they heard a 'cracking' sound coming from the existing balance weight small core (16mm diameter) polymeric insulator in the tail wire. Realising something was wrong, the OLE staff moved clear and the polymeric insulator then parted, causing the balance weight stack to descend to the ground releasing the OLE tensions.

- Small core (16mm diameter) WT Henley insulators Catalogue number 91/012574, manufacturer reference 56145-56 are NOT FOR FUTURE USE. The larger core (31.5mm) WT Henley insulator Catalogue number 91/010050, manufacturer reference 56146-65 shall be used.

- Check and quarantine ALL small core (16mm diameter) WT Henley insulators 91/012574 from Stores.
- The WT Henley insulator Catalogue number 091/012573 manufacturer reference 56145-8 which are NOT installed in the line are also to be quarantined.

- Where 16mm core diameter insulators are already installed in the line (e.g. in balance weight tail wires) these insulators shall be replaced with the 31.5mm core diameter version.

- Where a 16mm core diameter insulator is found as part of a balance weight assembly it shall be replaced prior to performing any work on the wire run. Staff shall be cautious when applying the Rig (not to introduce any shock loading into the insulator).
