Safety Alert

Overtured forklift truck

Ref: NRX21-11

Location: Holgate Depot, York

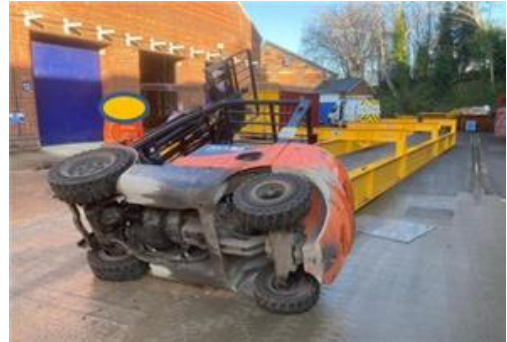
The team decided to lift, turn and carry the frame using two forklift trucks. The two trucks each had a different lifting capacity, one a 13 tonne and the other a 3 tonne safe working load. They were positioned each end of the load and each lifted the frame using a single-point lifting strap over their forks.

As the suspended frame started to turn, the smaller truck was pushed out of position and overturned. Fortunately, there were no injuries.

This was a complex, tandem lifting operation but there was no specific risk assessment or lifting plan. No-one was supervising the lifting operation.

- How do you recognise an operation which requires more specialised assessment and knowledge?
- What should you consider when planning a tandem lift?
- Who should you involve in assessing the risk in a complex lifting operation?
- How do you check you are using the correct tools and method for the activity?
- Do you know what must be done to report a RIDDOR reportable Dangerous Occurrence?
