URGENT – quarantine certain Lithium-Ion LED work lights

Ref: NRA22-04

Date of issue: 27/07/2022

Location: Northampton, North West & Central

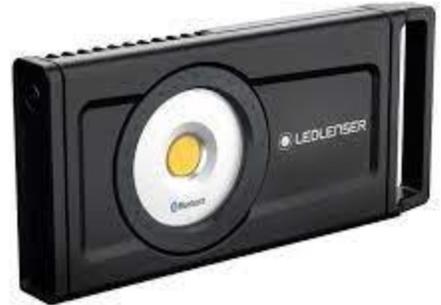
Investigation of the fire which destroyed a building at Network Rail's Northampton depot on 28 June has indicated a particular model of LED site light may be the cause. Evidence shows the fire started where Lithium Ion batteries from a Ledlenser IF8R task light were being charged. The fire could have started from the charging cable/plug or the batteries themselves. It is clear that the initial fire was made more intense by the batteries.

The lights were fairly new but depot staff had already changed how and where they charged the batteries because they became hot. The team had stopped charging them in vehicles and were charging them in the depot stores, positioned vertically rather than flat side down to limit heat transfer.

- Temporarily suspend purchase or use of any Ledlenser IF8R task lights.
- Quarantine all existing lights of this model. The battery should be removed from the light unit and both the light and battery should be placed in your usual quarantine area.
- Whilst in quarantine the battery must not be inside a metal container or allow contact with other battery terminals.
