## Cable breach during rail burning activity

Ref: NRB23-04

Date of issue: 17/04/2023

Location: Totnes, Devon

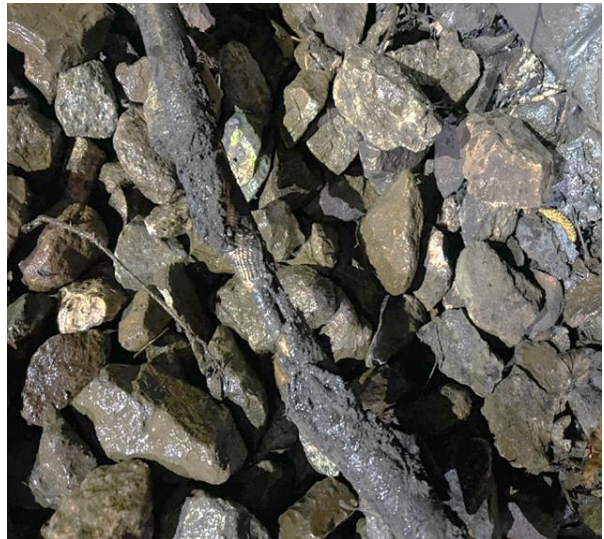
They couldn't see the 650v cable which supplied power to the signalling system. It was buried just under the surface of the wet ballast underneath the rail.

The cable had no protective routing and you could only see it intermittently on top of the ballast at points along the cess.

The cable sheathing was burnt through, causing a large bang and flash, and significant signalling power loss within the Totnes area.

All High Output rail burning activities have been suspended, while we review if any additional controls are necessary.
