# Calling TSA members How tidy is your site?"

#### Other notable incidents involving lineside rail

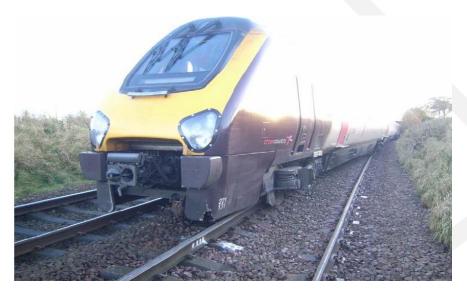
#### Innverkeilor 4<sup>th</sup> November 2012

As the train passed over the trailing points from the down sidings at close to the line speed of 80 mph, the left-hand front wheel struck a 60cm section of rail that had been deliberately placed as an obstruction in the crossing. This resulted in the front of the train rising up, with the leading bogie derailing into the six-foot.

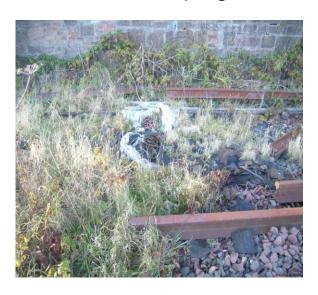
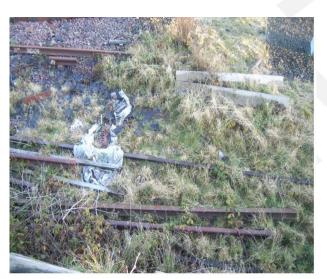
- Unmanaged scrap and waste material is a significant contributor to Slip, Trip and Fall events hurting our workers.
- Many accidents are caused or aggravated by untidy conditions on site.
  There is duty for all of us to keep our workplace safe and in good order.
  Good housekeeping is essential in running a safe site.

- Clearly identify existing scrap rail, and implement an agreed plan for removal prior to construction work.
- Have a plan for removing any other scrap generated by your activities immediately upon completion (including approved lift plan)
- Don't rely on others to clean up for you, it is your responsibility.
- Only use planned setting down areas for new materials and scrap storage.
- Regularly clear up

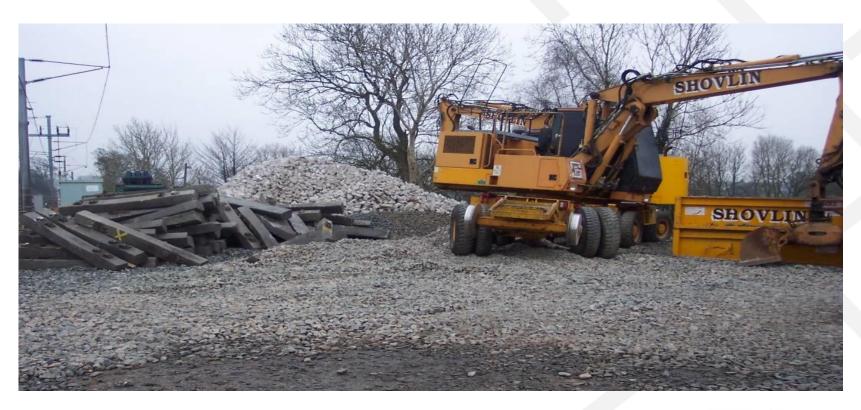
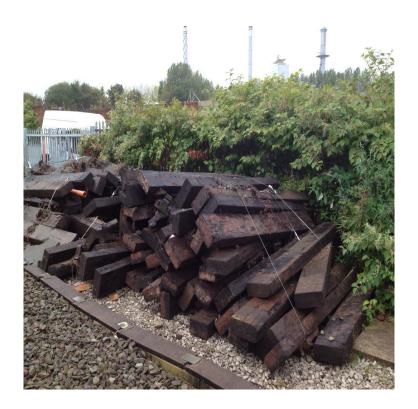
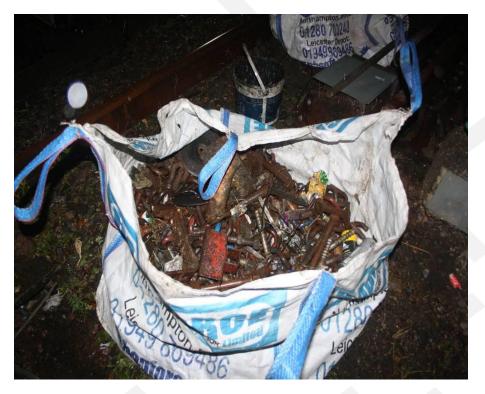
### Is it just Scrap Rail?

#### •Thousands of pieces of discarded scrap materials are usually littered around site

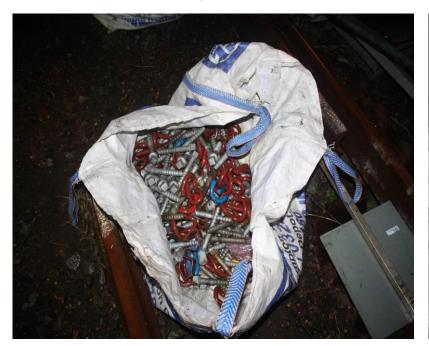
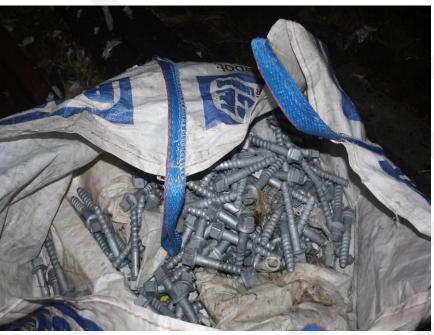
#### It's not just scrap, this is new equipment!

- •These were left line side and will now be returned to Maintenance stores.
- •They were a hazard in some locations, unsightly in others.
