# Christmas 2016- New Year 2017 Health and Safety Overview

# Near Miss- Ladbroke Grove 30 Dec

# Lost Time Injuries- High Potential incident- Shenfield Station, Crossrail Anglia

# Points Run Through

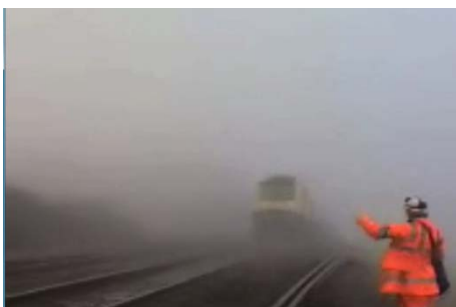
**NB photo not of incident- highlighting lack of visibility in fog**

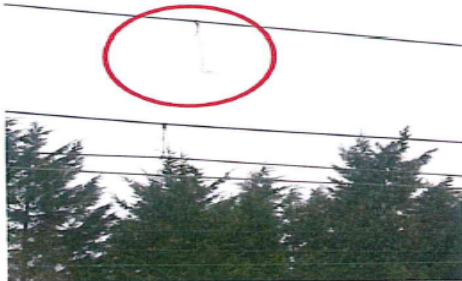
On 01/01/2017, at approximately 06.30hrs, A gang of permanent way operatives were working on the Up Electric lines located towards the London end of Shenfield Station Platform 4. On the adjacent lines, an OLE team of 3No MEWPS were carrying out preparation for the de-wiring and removal of the existing OLE wiring systems. Whilst the preparation operations were undergoing, it appears that the existing OLE dropper suffered a shear failure causing the OLE to drop instantly and the remainder of the OLE to fall downward, the existing radius of the wiring allowed the cables to straighten and move across from the Down Electric to the Up Electric causing it to swing sharply hitting 2No of operatives working as part of the P/way gang on the Up Electric.

Failed Dropper

The initial investigation shows that the existing OLE dropper had suffered shear forces during the dismantling works causing the main Auxiliary wire to drop instantly and swing to the adjacent Up Electric line striking the operatives.

Failure of the shear dropper causing the contact wire to drop.

- Exclusion Zones for all de-wiring are enforced
- Consider radial forces when deciding the size of the exclusion zone

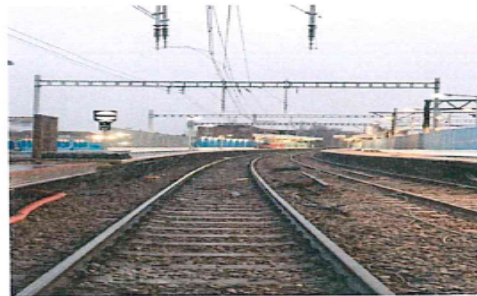
Worksite Location

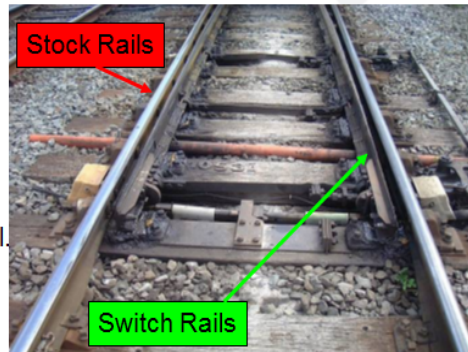
Damage occurs when either the rail wheels of a machine contact the point ends and distorts them or when the machine derails bending the switches as the wheels of the machine derail between the switch rail and stock rail.

### Stretcher Bar Damage

- Life Saving Rule "Never undertake a task unless you are trained, assessed as competent, and have the correct equipment"
- Ensure that your points operators and ES's are following points protocol- Rule Book GE/RT8000/HB4
- <https://safety.networkrail.co.uk/tools-resources/keypoint-cards/>
- Ensure appropriate equipment is available and easily accessible

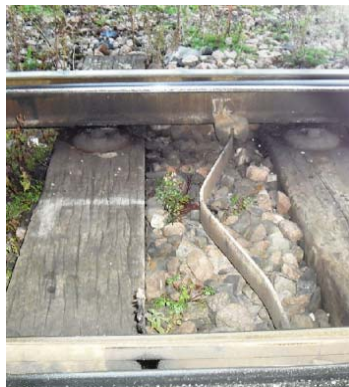
Facing set of points, when the switch rail is not set correctly against the stock rail thus allowing the rail wheel to spilt the points

### Rail Wheels Splitting Points
